FACILITY CONDITION REPORT Appendix B to Concept Report

Prepared For:

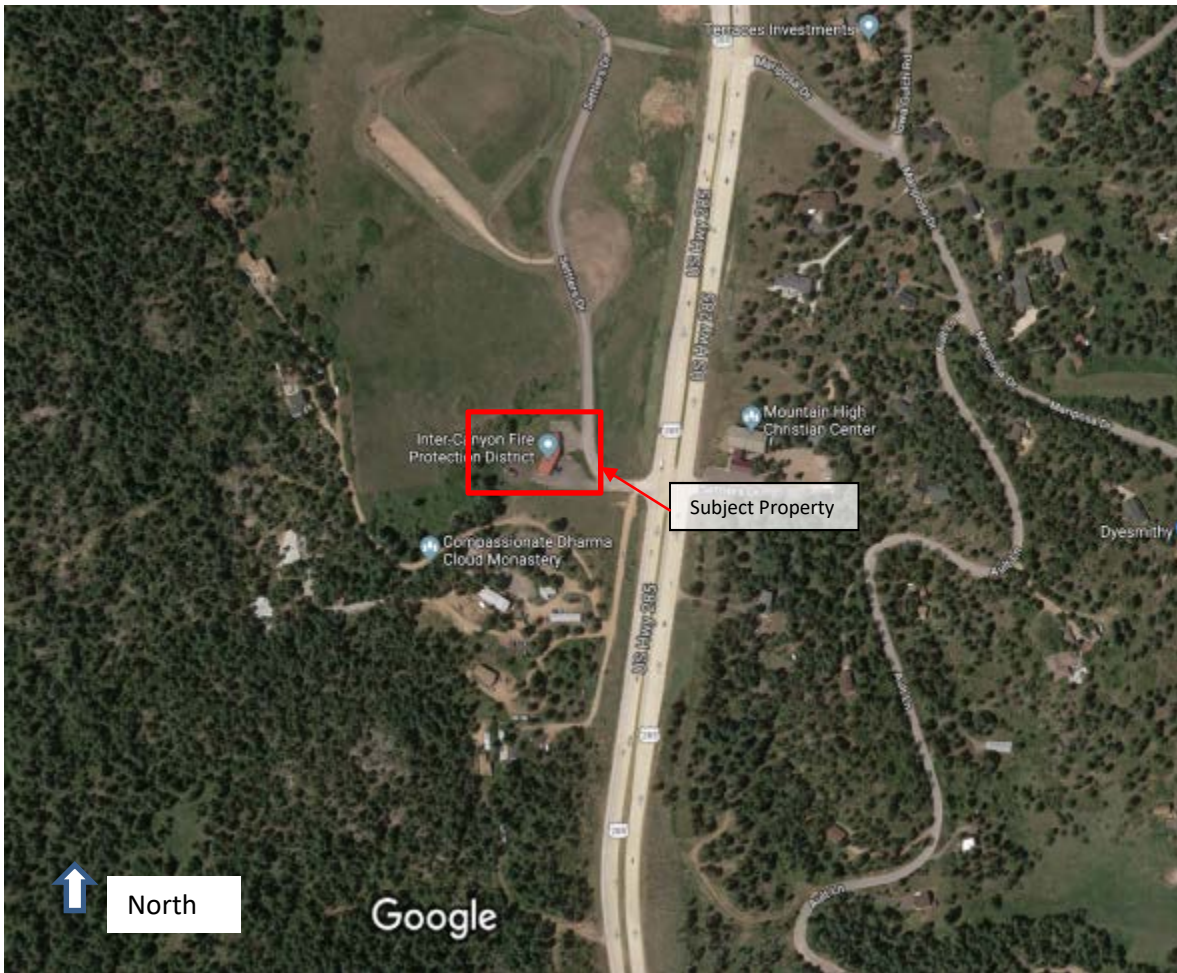
The property is comprised of two sections, the south section which is the original structure, one-story, wood framed and the addition (north section) which is a single-story pre-engineered metal building. The combined square footage was determined to be approximately 4,275 ft². Refer to Appendix A for diagrammatic floor plan.

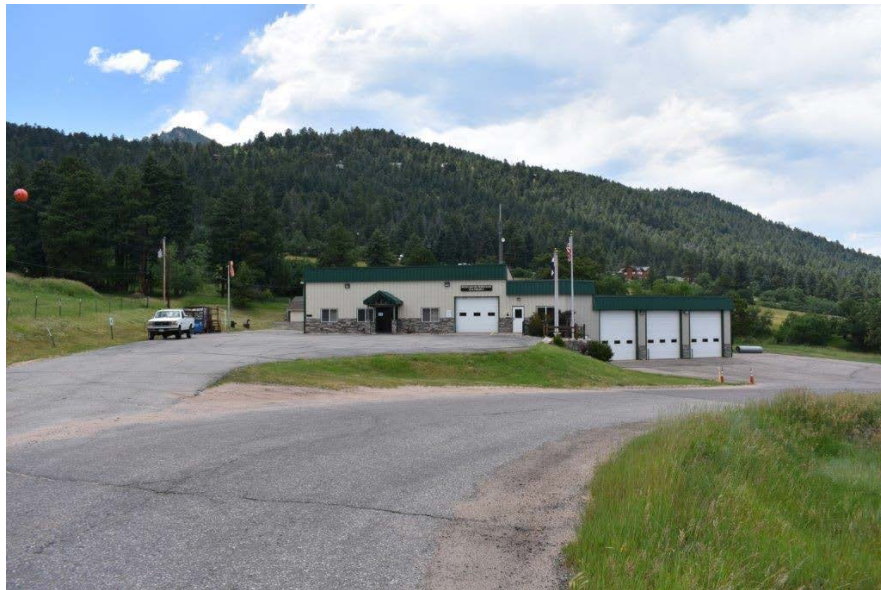
Picture #4.1 – East side, drains to the east.

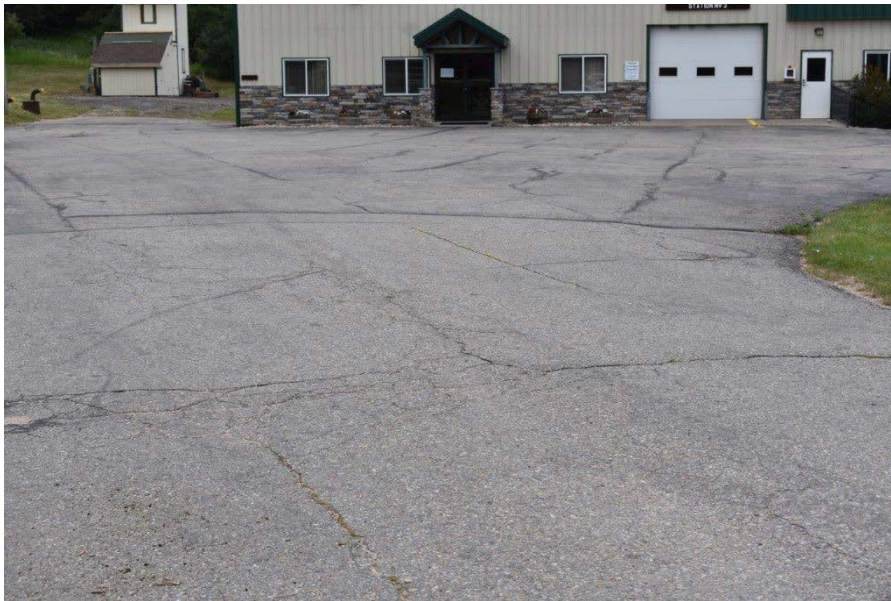
Picture #4.2 – Asphalt is in poor condition. Numerous areas of cracking, alligatoring, and in overall poor condition.

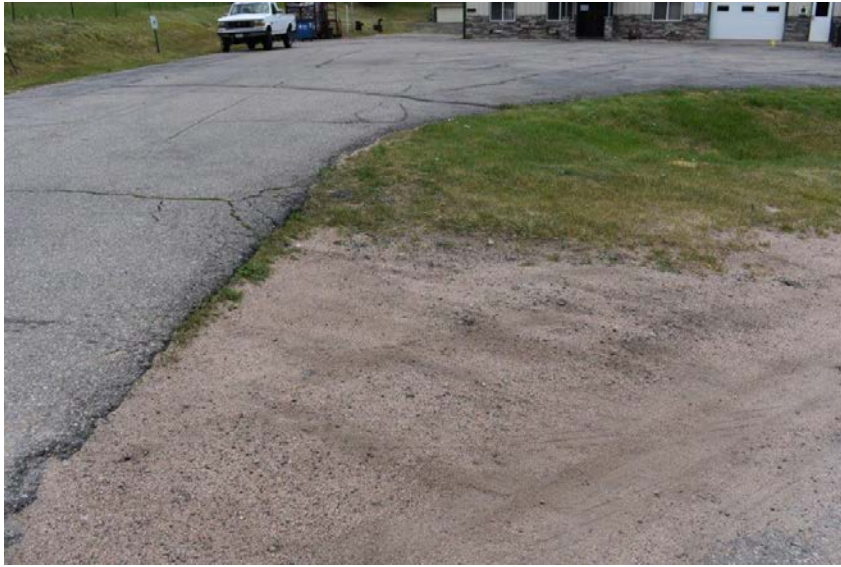
Picture #4.3 – Numerous areas of deteriorated asphalt and areas that should be asphalted.

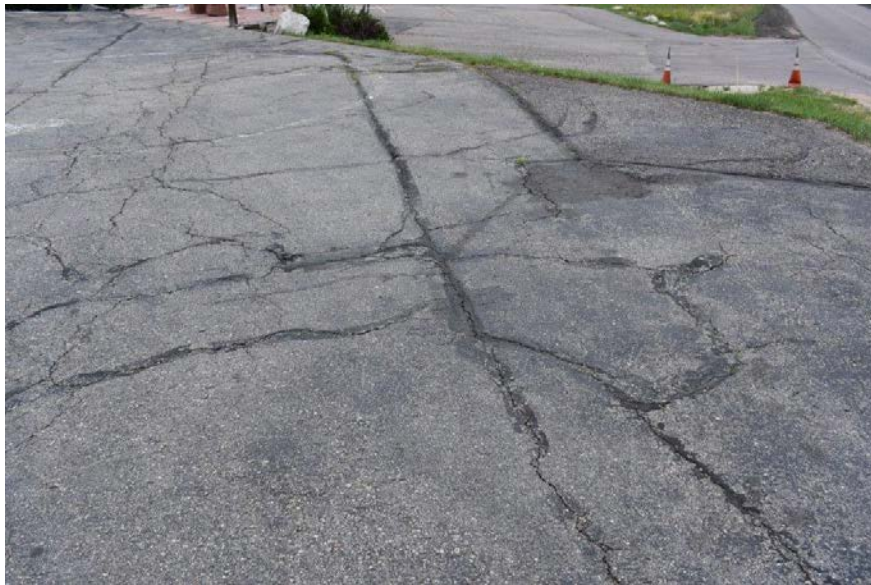
Picture #4.4 – Evidence of poor asphalt.

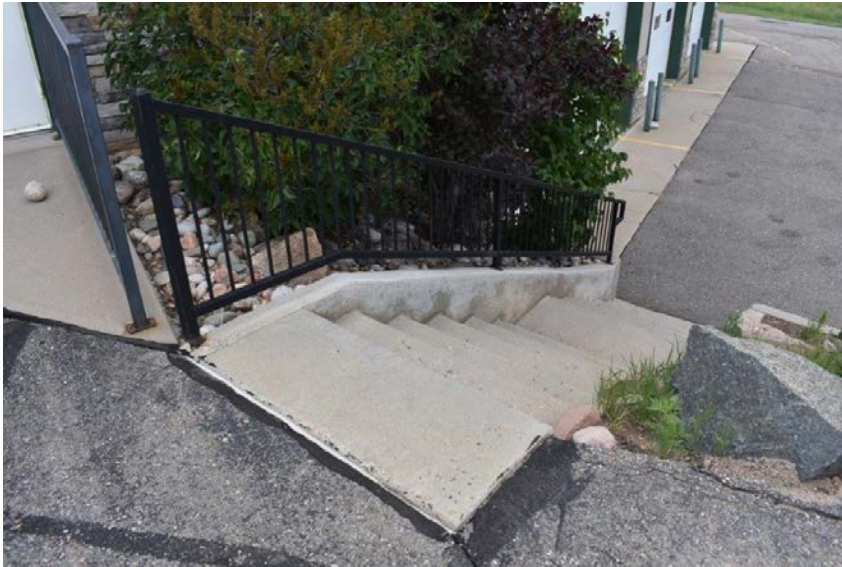
Picture #4.5 – Exterior concrete steps, are non-code compliance and concrete is in poor condition.

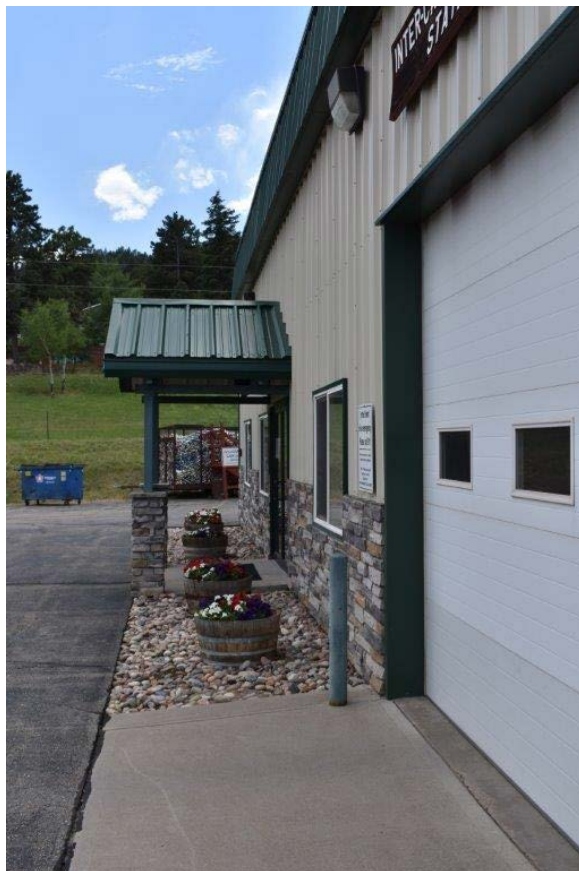
Picture #4.6 – Concrete apron to the EMS bay. Recommend that the concrete to asphalt interface be properly sealed

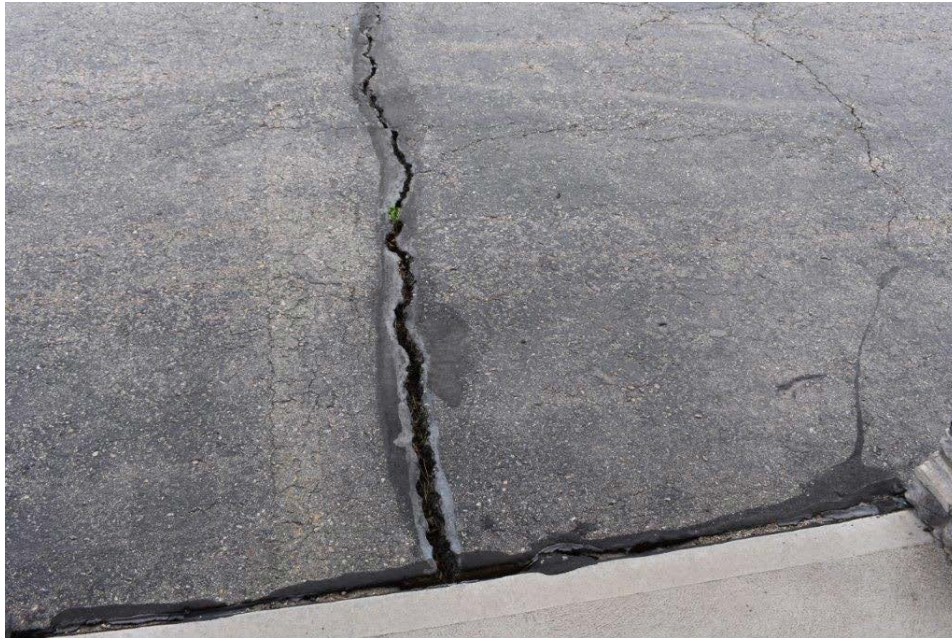
Picture #4.7 – Severe asphalt cracking. These cracks allow water to infiltrate into the subbase beneath and caused more deterioration of the asphalt.

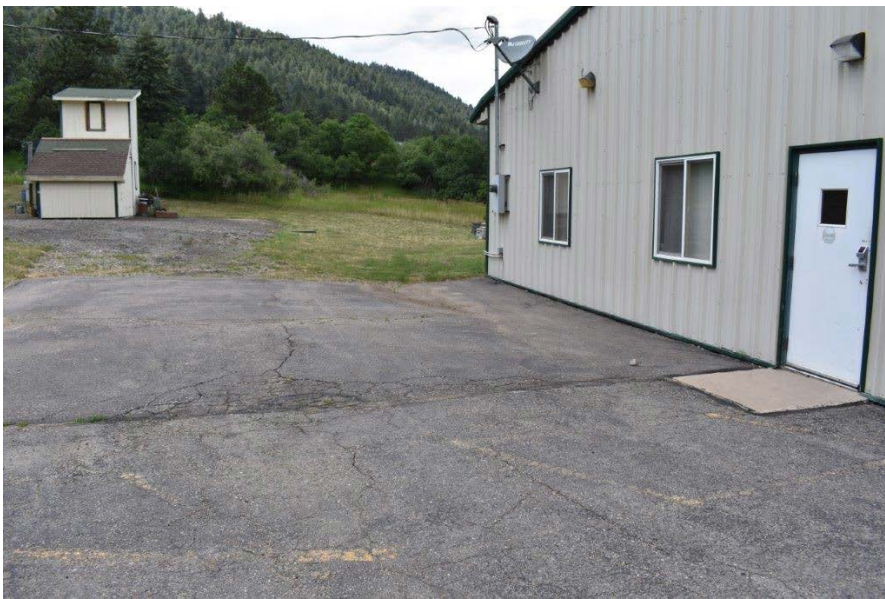
Picture #4.8 – More severely deteriorated asphalt. This area also has poor drainage. Gradient is back to the building which is a problem.

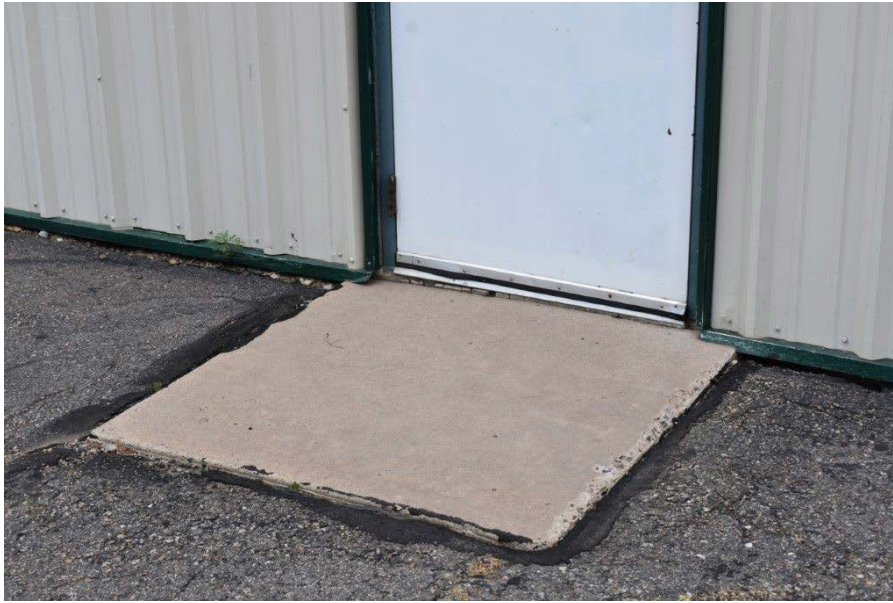
Picture #4.9 – Concrete entrance pad, south door, concrete in poor condition, also the elevation between the concrete and asphalt causes a trip hazard.

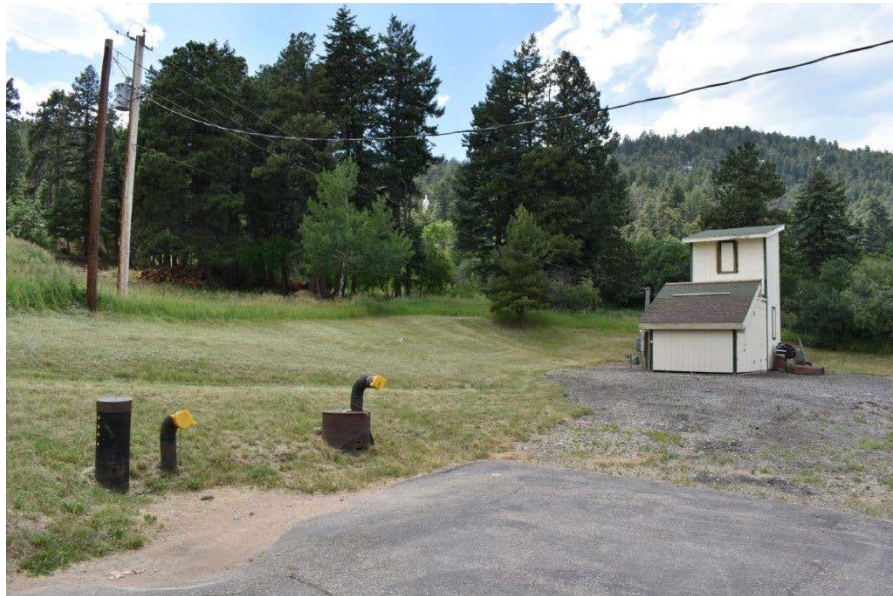
Picture #4.10 – This area represents the training prop area. Asphalt issues, grading issues, site should be paved or a suitable improved surface be installed.

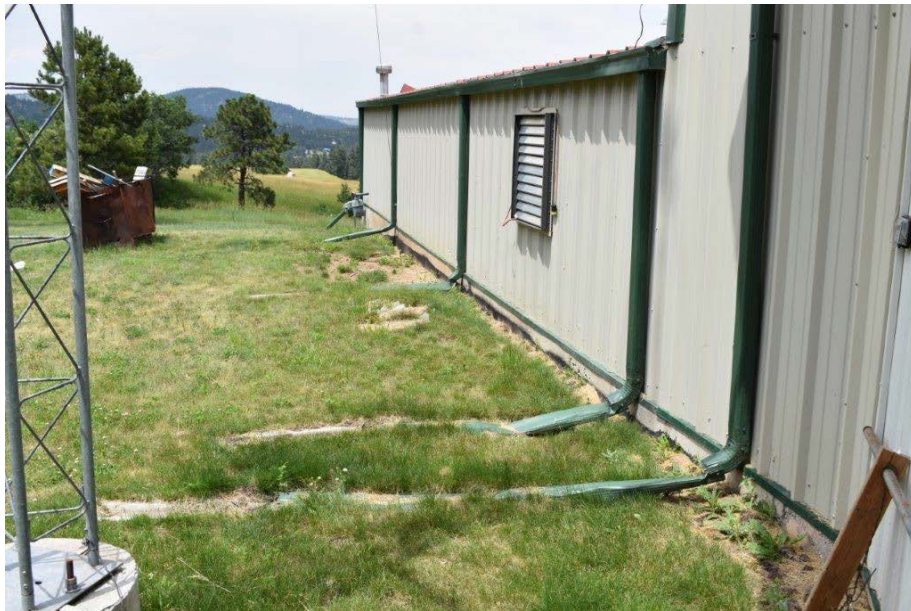
Picture #4.12 – Roof drainage system is damaged, allowing stormwater to collect at base of the building.

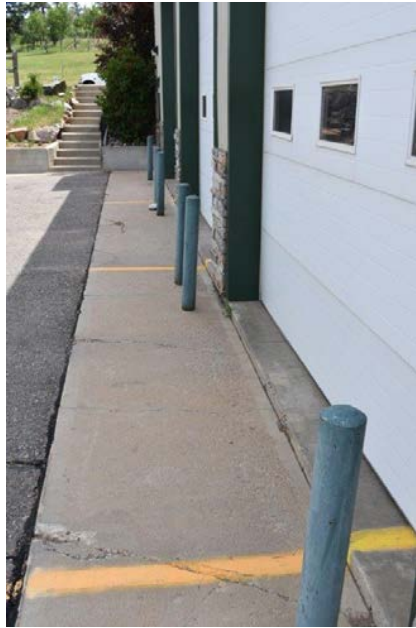
Picture #4.13 –
Concrete apron pan,
lower level, east side.
Concrete is in poor
condition, numerous
cracks and structural
damage.

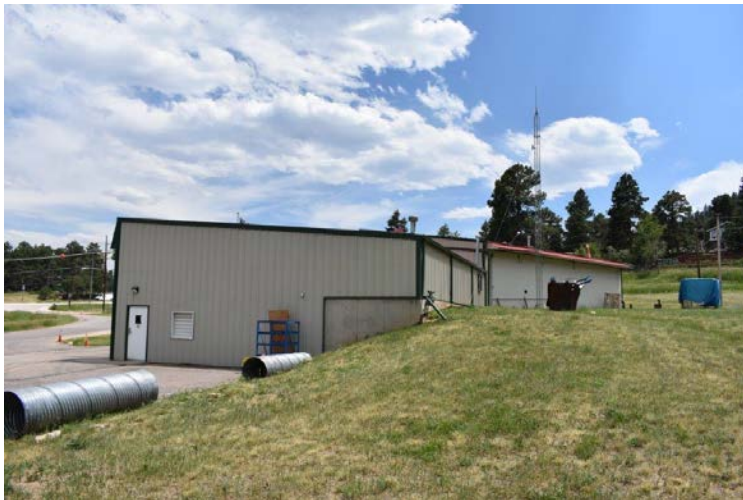
Picture #5.1 –
Foundation wall north
section, no concerns
noted.

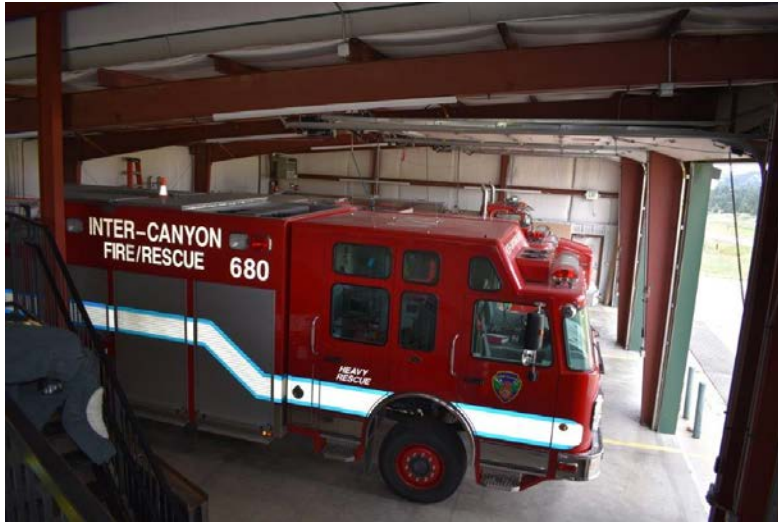
Picture #5.2 – General overview of the structural elements associated with the north section. No concerns.

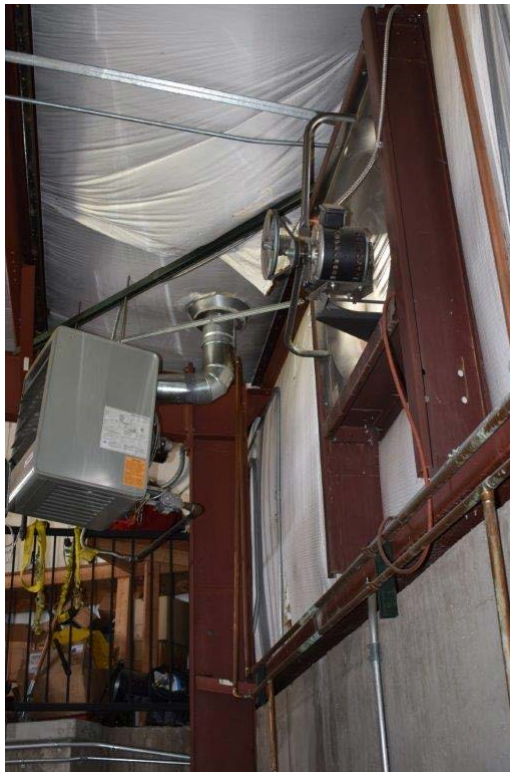
Picture #5.3 – Wall framing and concrete retaining wall, north section, no concerns noted.

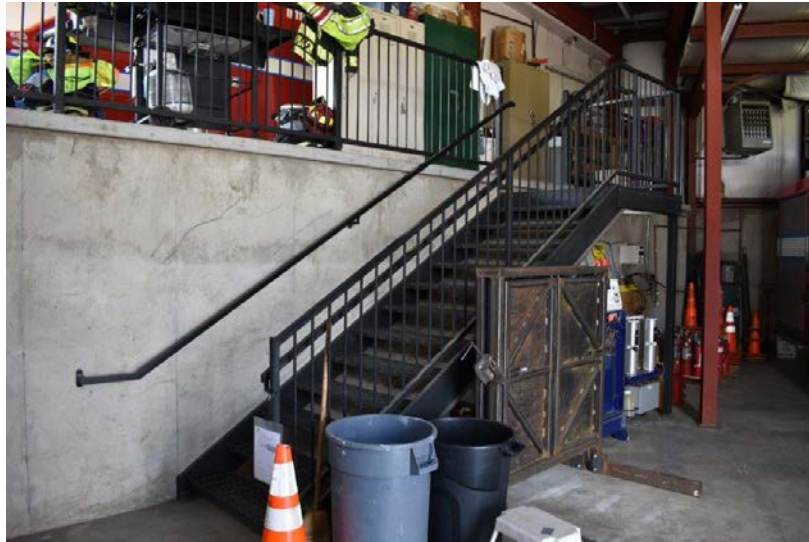
Picture #5.4 – Concrete wall between north and south section, no concerns noted.

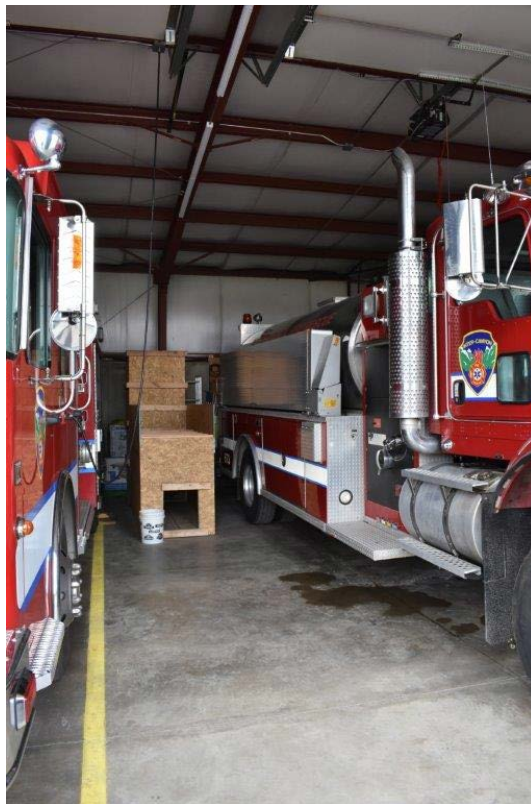
Picture #5.6 – Concrete floor, north section. In good condition.

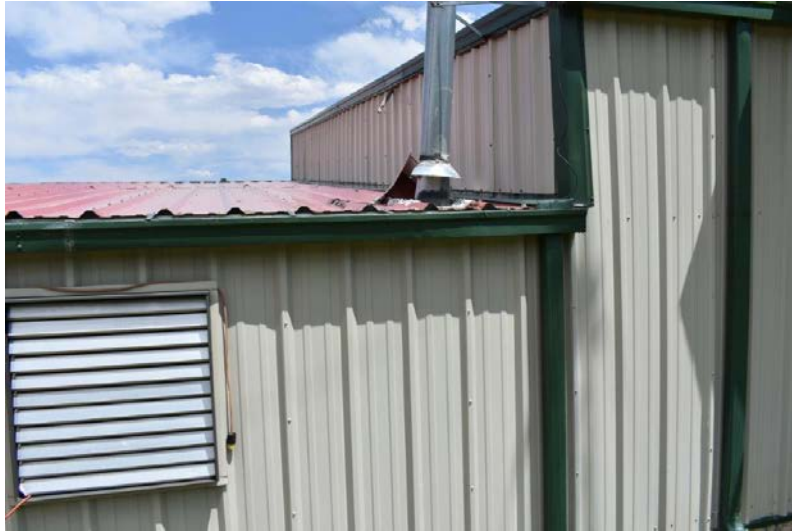
Picture #6.1 – Envelope detail, siding is in fair condition, but there are areas subject to weather infiltration.

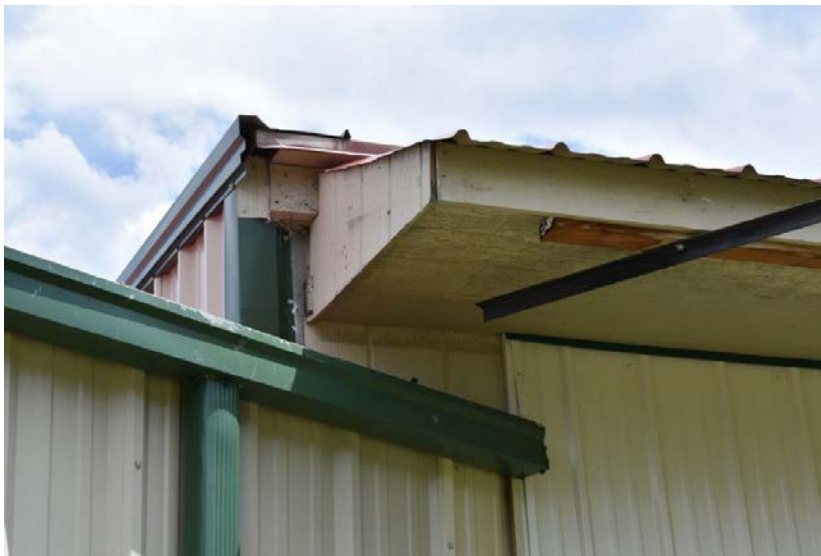
Picture #6.2 – Areas of the exterior envelope, south section are exposed wood in poor condition and poor flashing details. It is recommended this overhang be removed.

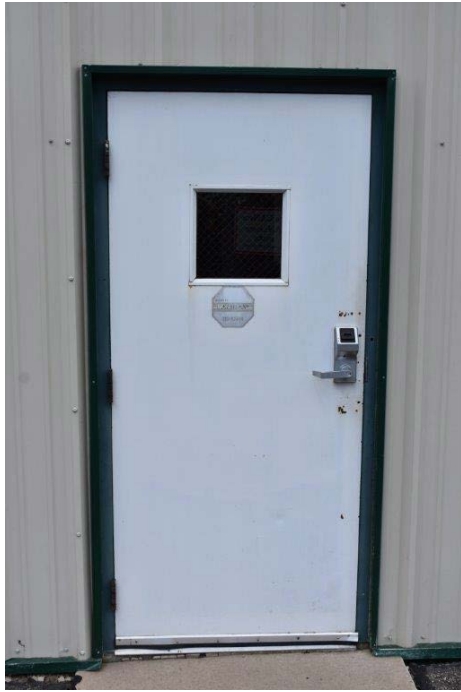
Picture #6.3 –Man-door, south side, in poor condition.

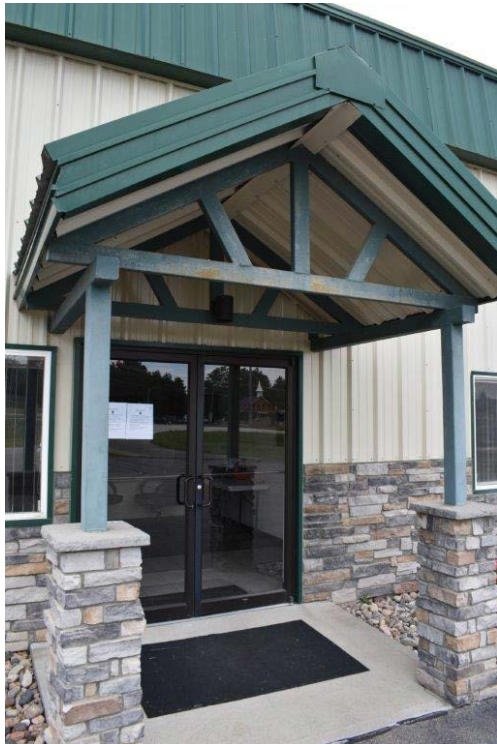
Picture #6.4 – Main entrance and entry in good condition.

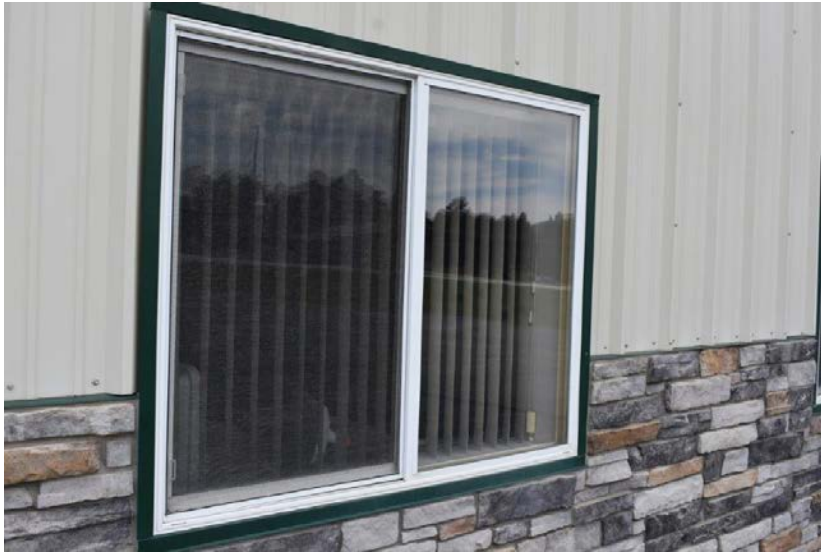
Picture #6.5 – All windows are residential grade, vinyl sliders, in fair condition. It is recommended the windows be upgraded.

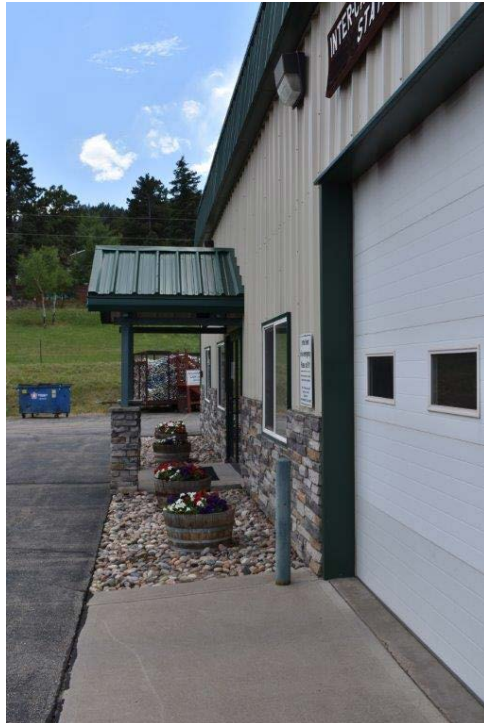
Picture #6.6 – Overhead doors are generally in good condition. It is recommended that they all be re-sealed.

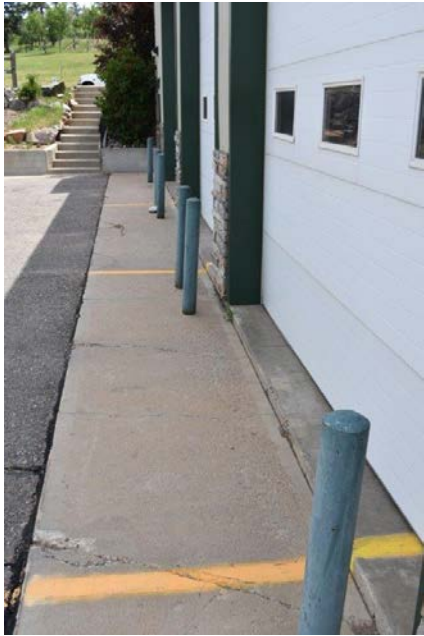
Picture #6.7 – Re-sealing of overhead doors is recommended.

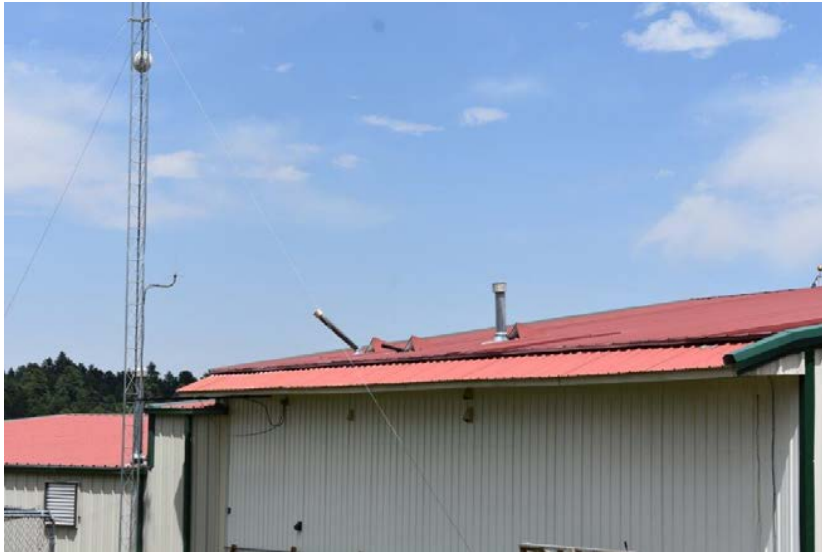
Picture #7.1 – View of the roof, south section. This is a miss-matched culmination of different roofing pitches and as such different flashing. It is recommended this roof section be re-installed and improved.

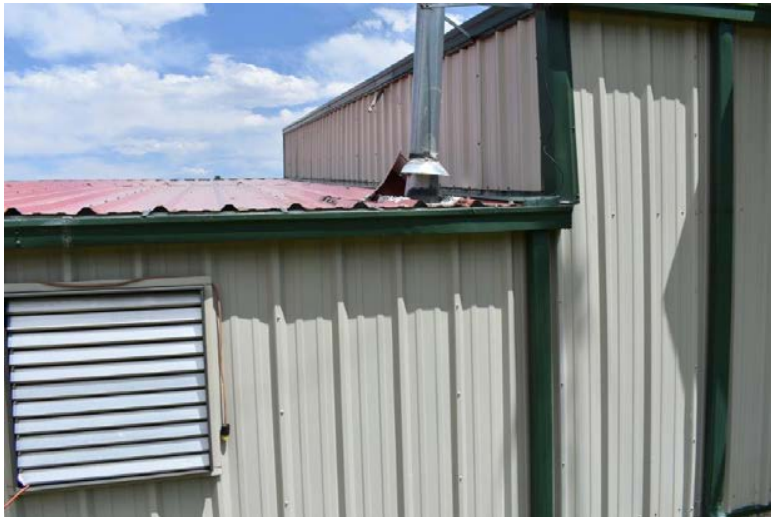
Picture #7.2 – Flashing around the vent stakes is poor and needs to be properly flashed.

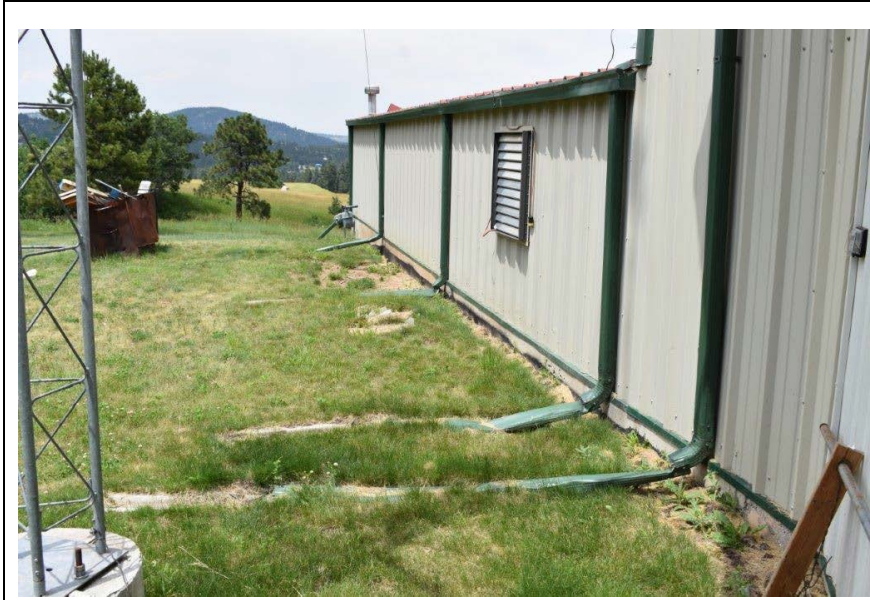
Picture #7.3 – The roof drainage system is deteriorated, damaged, and needs replacement. This is causing improper roof drainage and conveyance problems.

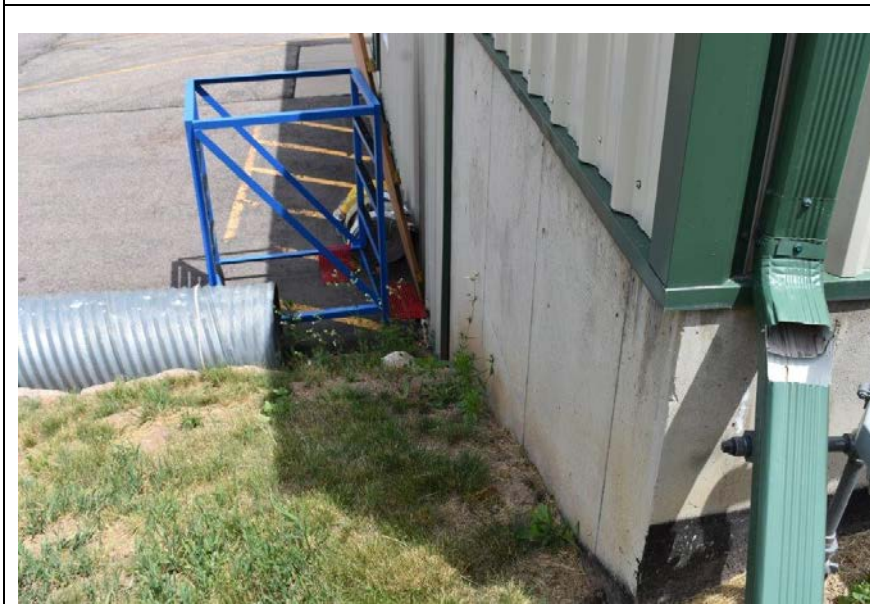
Picture #7.4 – Recommended that this downspout be repositioned to convey water away from the building foundation.

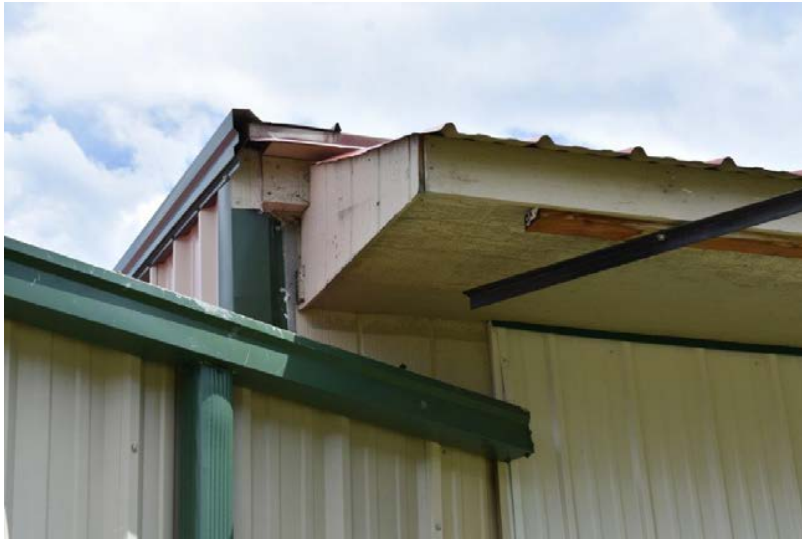
Picture #7.5 – It is recommended that this overhand be removed and properly re-constructed and flashed.

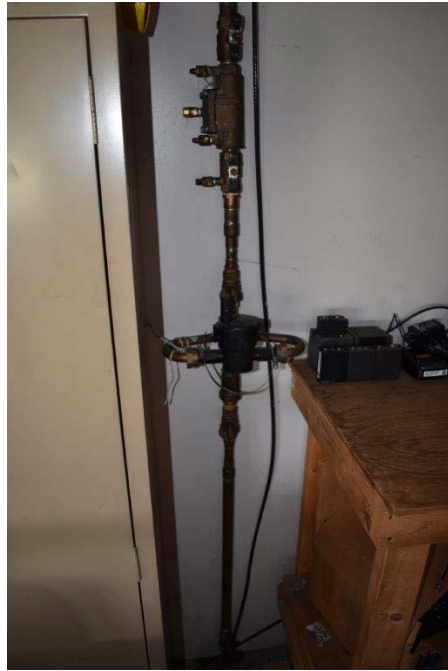
Picture #8.1 – Water service, no concerns. It should be noted that the backflow preventer is protecting the supply side of the water supply only, not the building side.

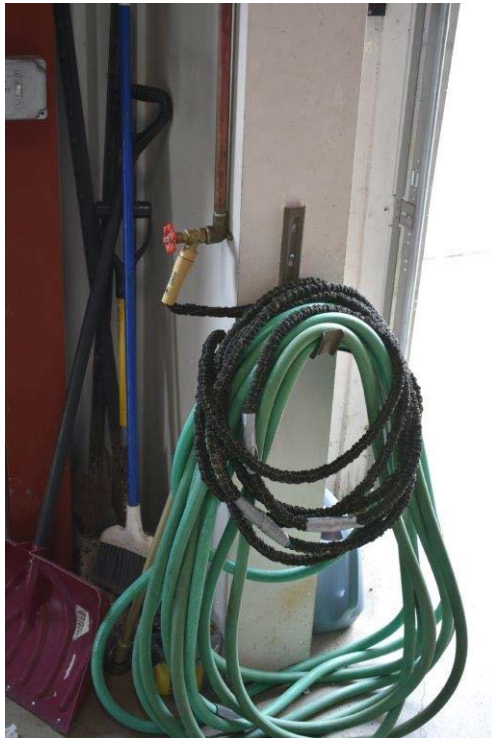
Picture #8.2 – It is recommended that all hose connections be fitted with a vacuum breaker to avoid contamination back into the building water distribution system.

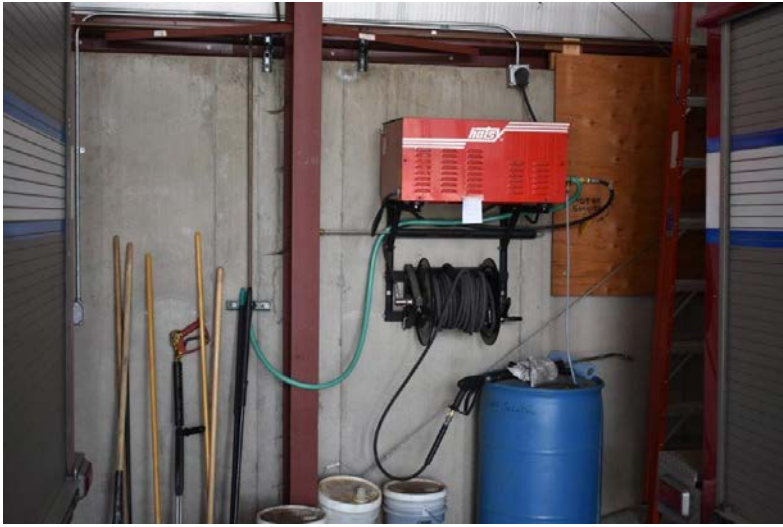
Picture #8.3 – Refer to picture #8.2, recommend a backflow preventer.

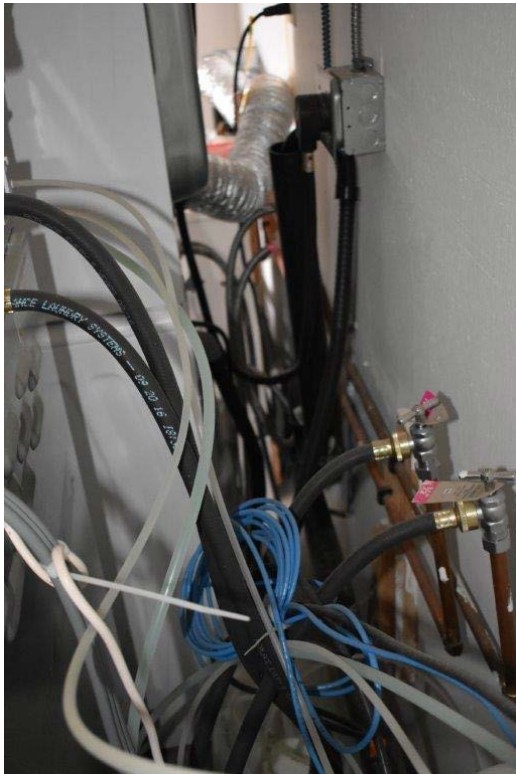
Picture #8.4 – All exposed copper piping should be insulated. Also the standpipe for the washer is not code compliant.

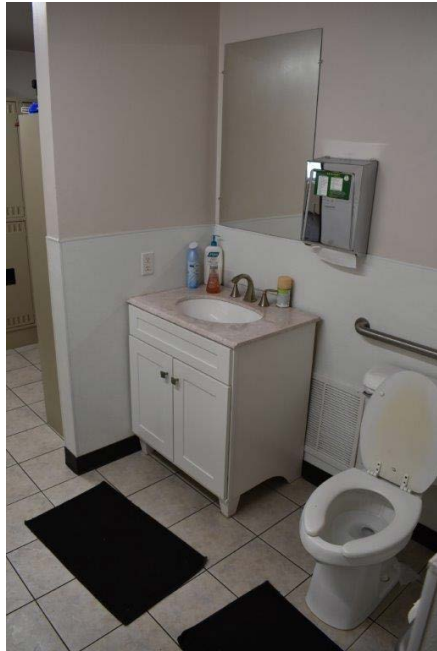
Picture #8.5 – Restroom fixtures. Recommend replacement and upgrade. Fixtures are not ADA compliant.

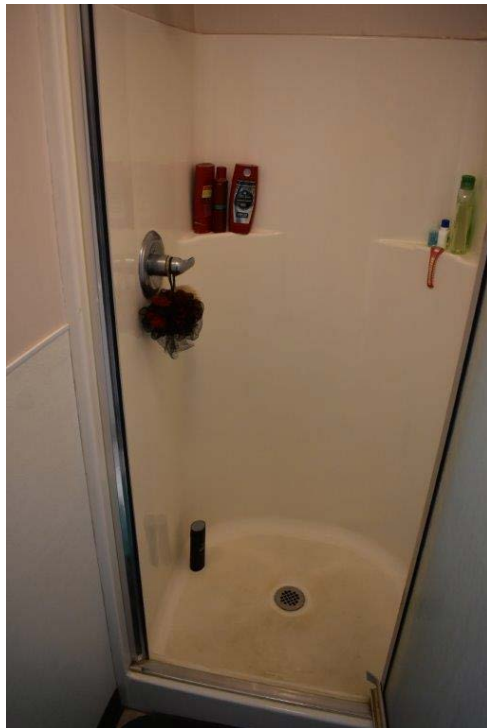
Picture #8.6 – Shower unit, not ADA compliant.

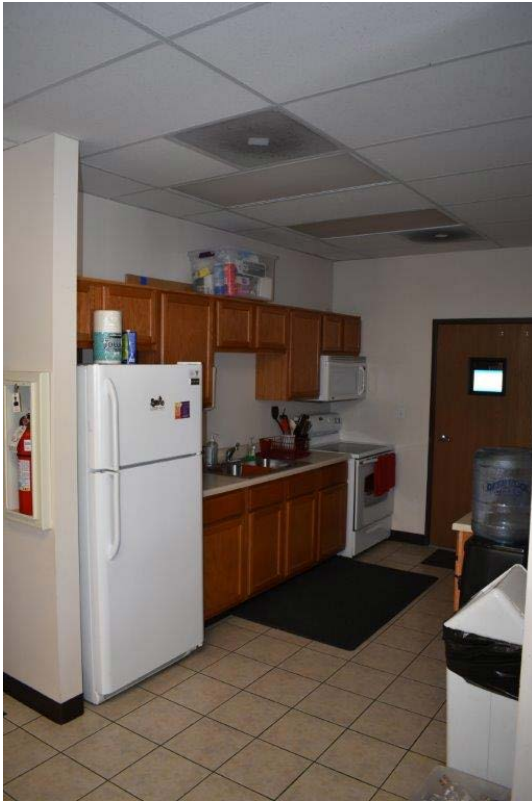
Picture #8.7 – Sink is functional. No concerns noted.

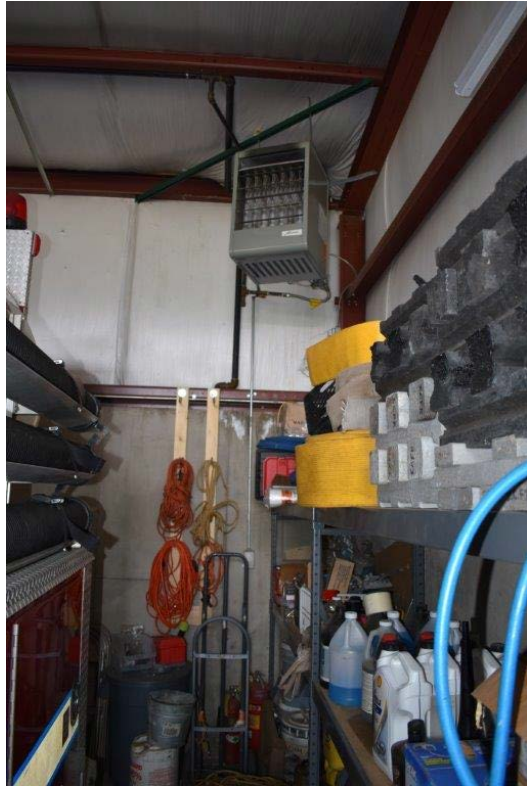
Figure 9.1 – Convector unit in the apparatus bay. Recommend replacement.

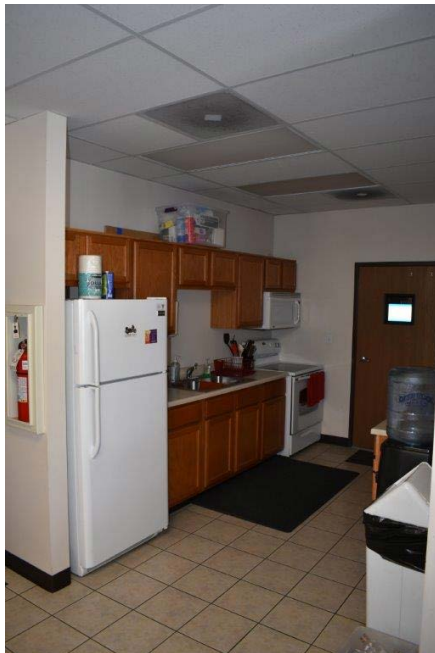
Picture #9.2 – The duct system the admin wing is in need of cleaning, is inefficient and recommend replacement.

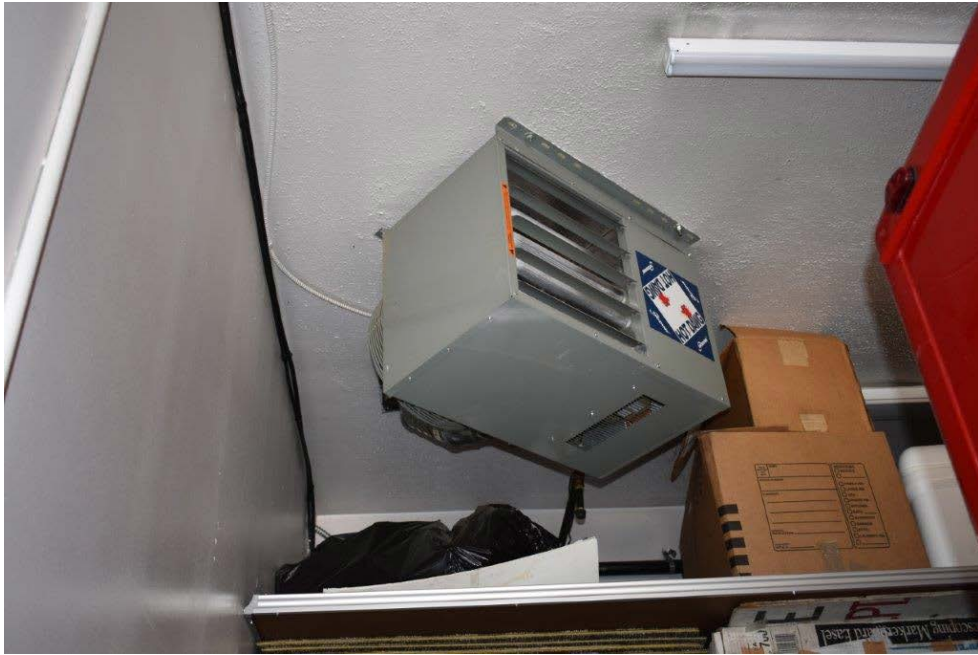
Picture #9.3 – Electric powered convector in the apparatus bay, very energy inefficient recommend replacement.

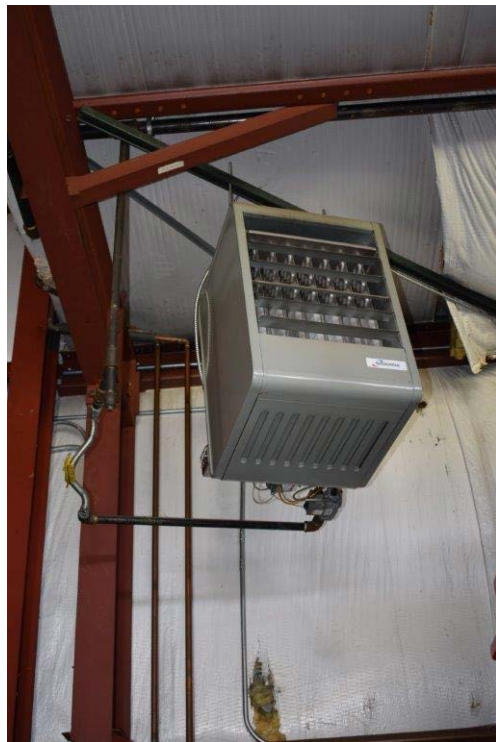
Picture #9.4 – The third convector in the apparatus bay

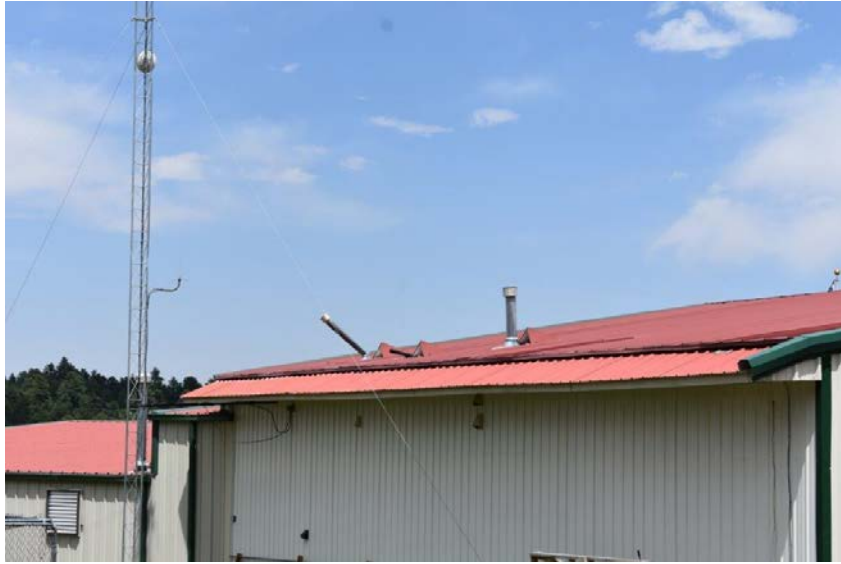
Picture #9.5 – One major concern is the venting of the water heater and furnace in the admin wing. These vents need to be vertical. This could cause an indoor air quality concern and a life-safety issue.

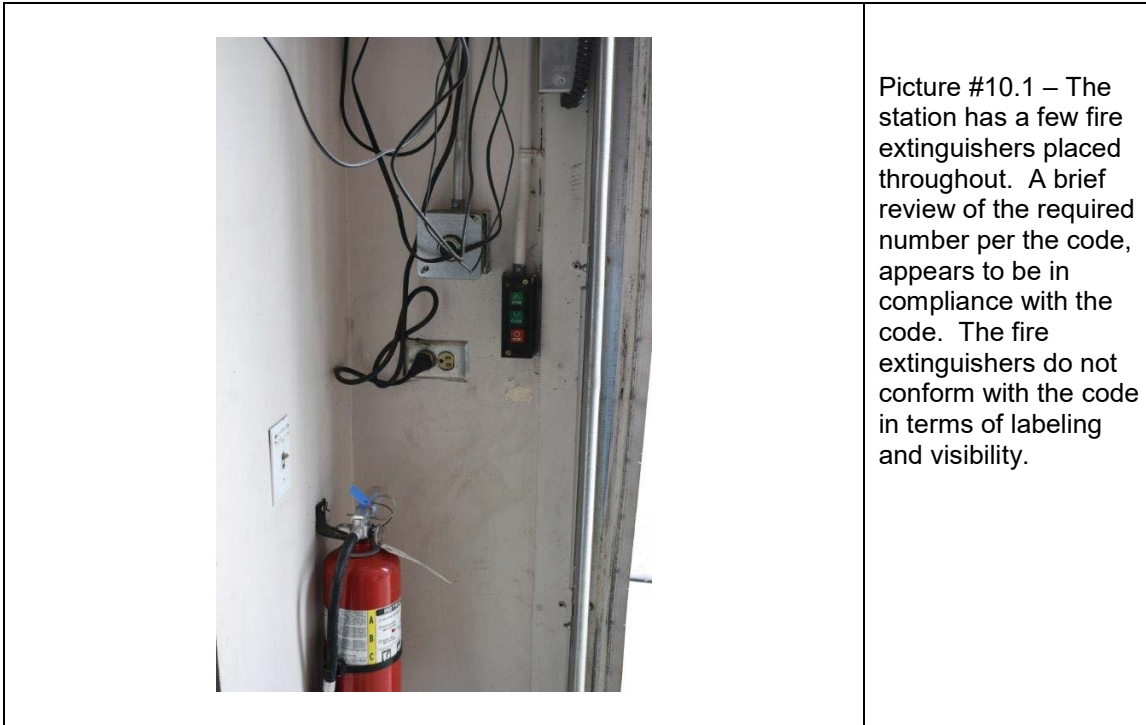
- 10.1 The building is not fitted with an automatic fire suppression system or alarm system. The facility does have fire extinguishers and smoke detectors located in the administration part of the building.

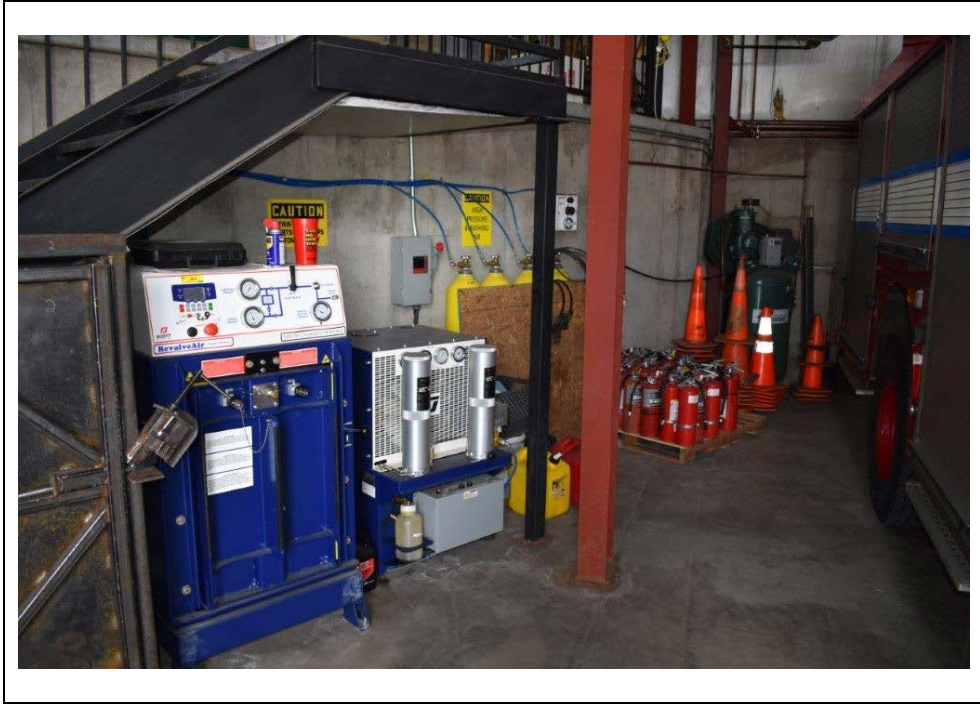
Picture #10.2 – The apparatus bay is used for storage, it is recommended that storage related items not be stored in the apparatus bay. This creates a hazard.

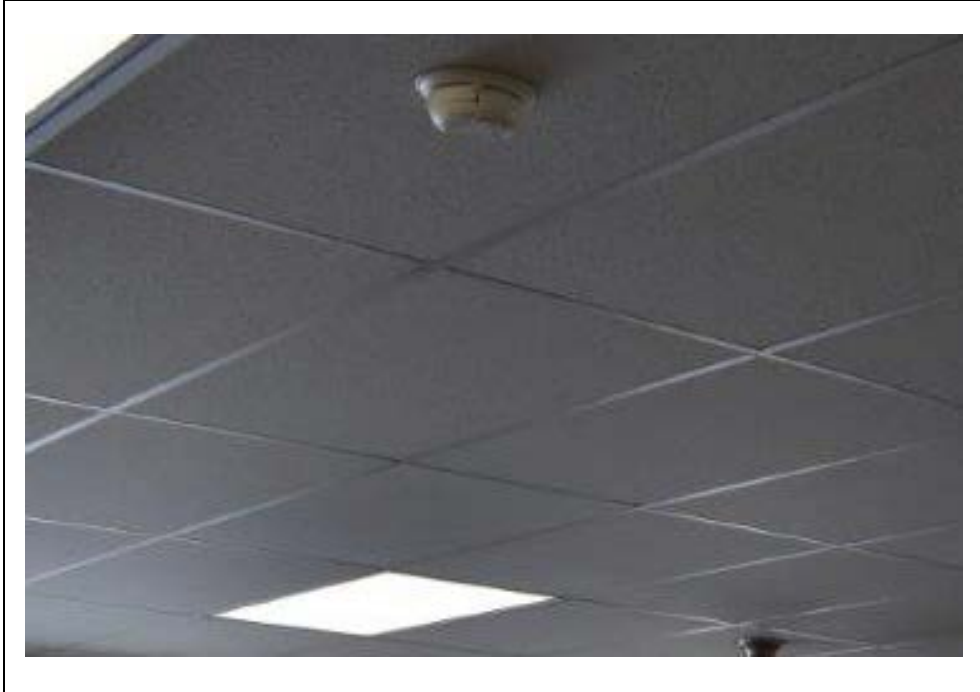
Picture #10.3 – There are smoke alarms in the administration area. Note the dormitory rooms are not properly protected in terms of fire/smoke/CO alarms.

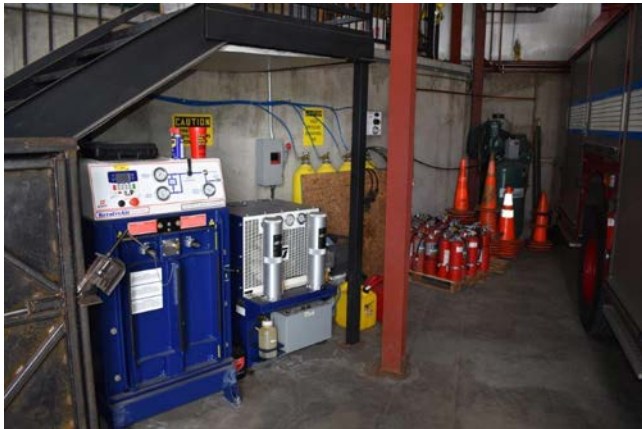
Picture #11.1 – The SCBA machine, was not inspected specifically in terms of its operations, but it was viewed in the context of the apparatus bay as a whole and the placement of the SCBA machine. It is highly recommended that since the SCBA machine is used to fill first responder air tanks that it not be located in an area that is identified as a “hot” zone for air quality, e.g., the apparatus bay.
