FACILITY CONDITION REPORT Appendix B to Concept Report

Prepared For:

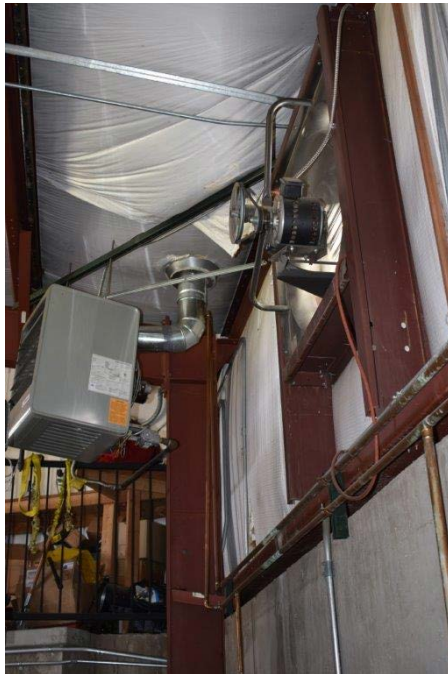
Picture #11.2 – The apparatus bay is fitted with an exhaust system. The air exhaust system appears undersized. It is recommended that the sizing be evaluated

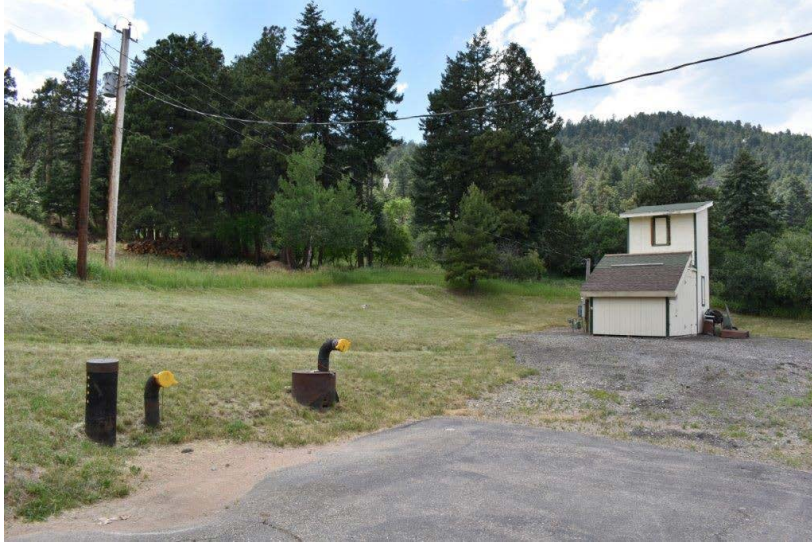
Picture #12.1 – Main service power pole.

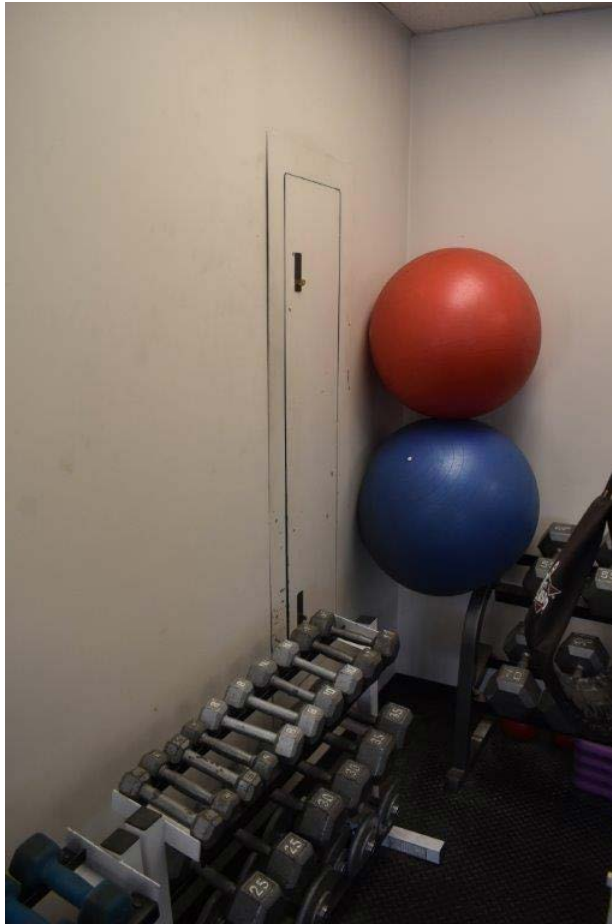
Picture #12.3 – Main disconnect panel is obstructed, this is a code violation.

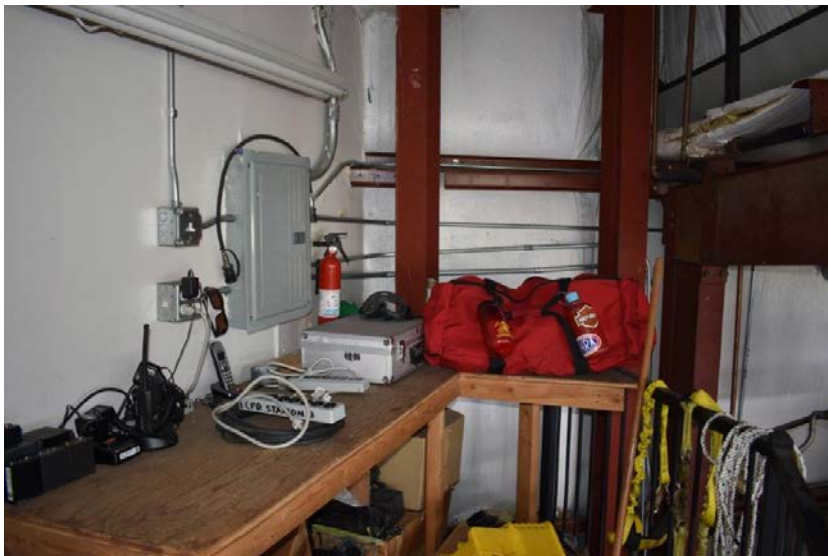
Picture #12.4 – Sub-panel, proper clear space is not provided. This is a code violation.

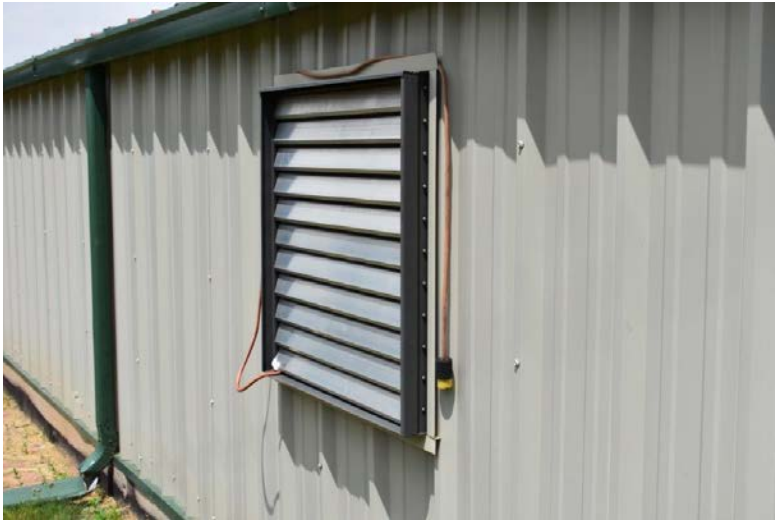
Picture #12.5 – Improper use of an extension cord, life-safety hazard.

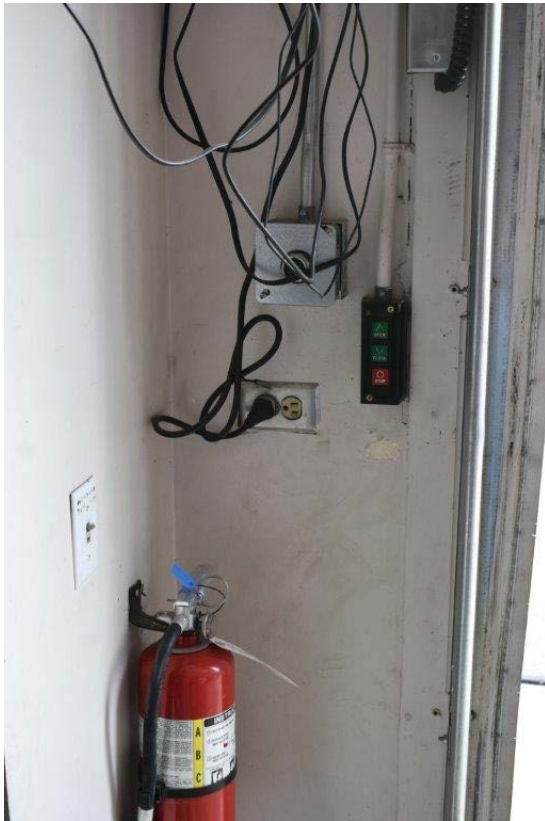
Picture #12.6 – Wires are not properly terminated. Safety hazard.

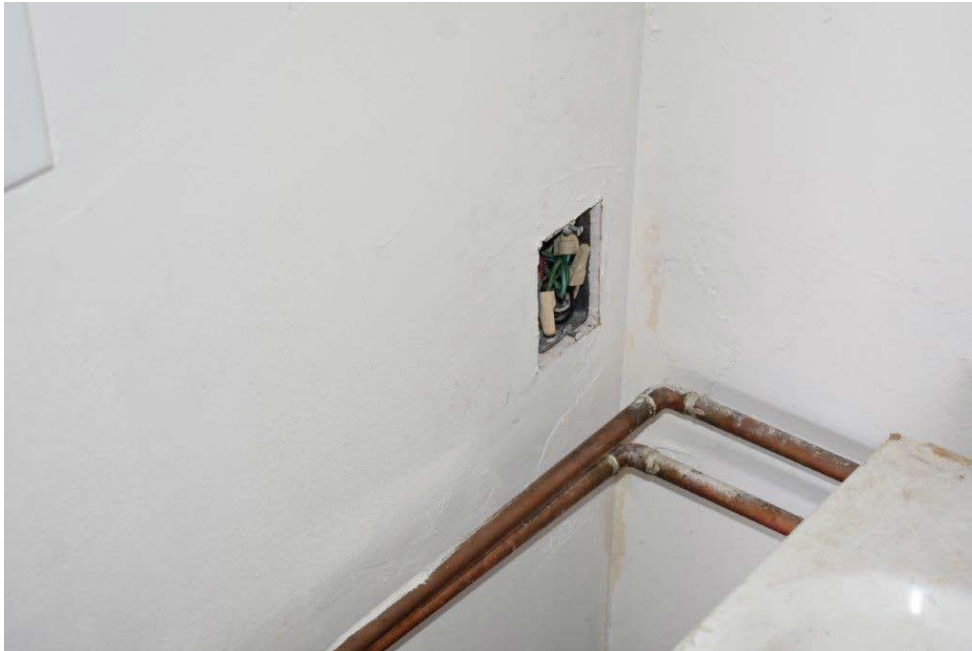
Picture #12.7 –
Missing a cover plate.

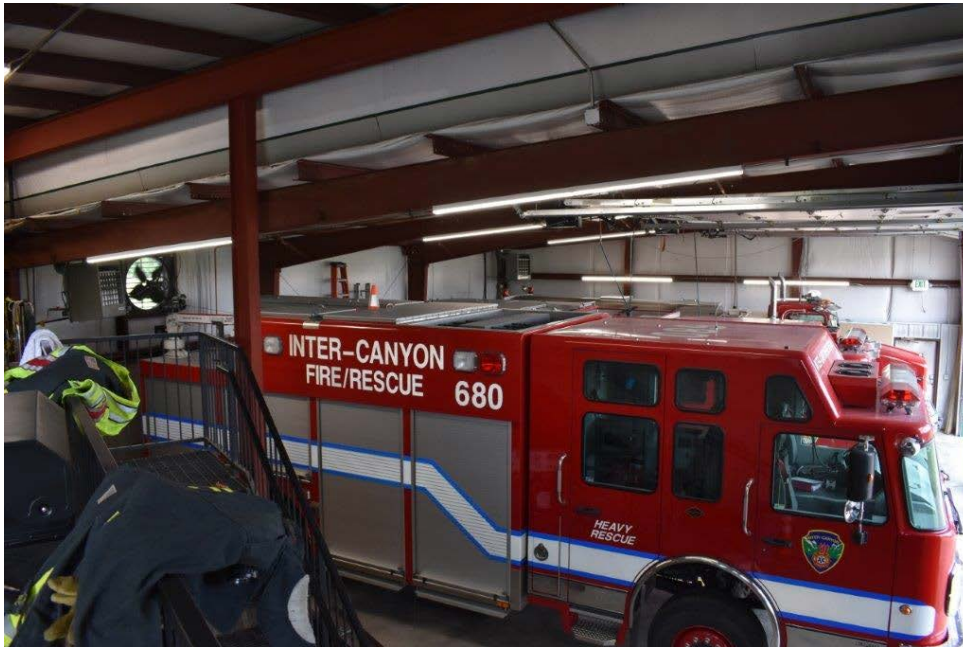
Picture #12.8 –
Apparatus bay
lighting. Poor lighting
for apparatus bay.

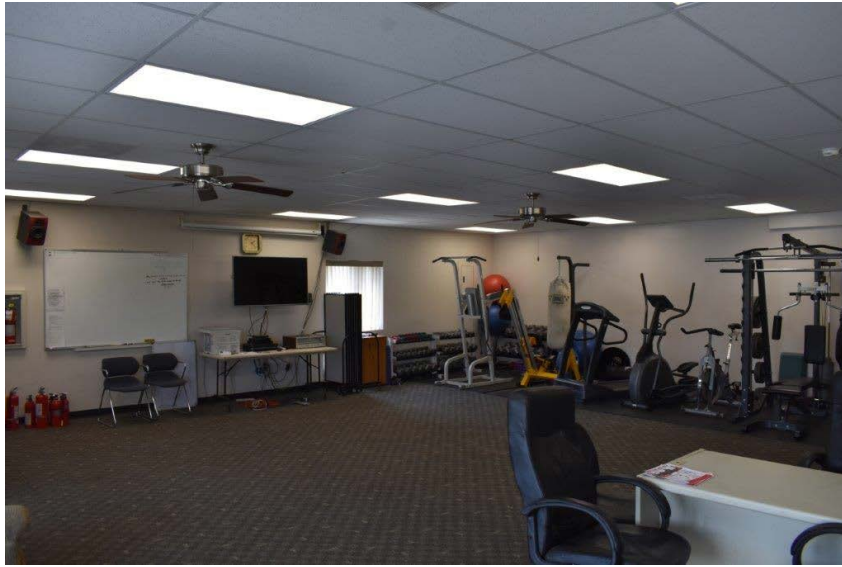
Picture 12.9 – Lighting in the administration wing is standard T8 lamped 2x4 troffers. It is recommended these be converted to LED fixtures.

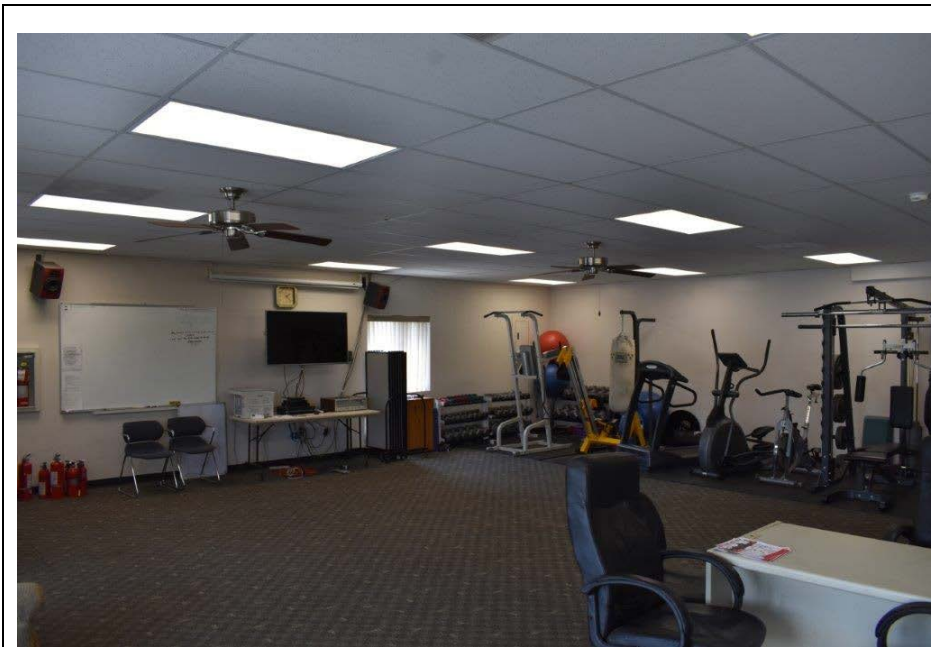
Picture #13.1 – Open floor plan in the south section. Used for meetings, PT, office space, etc. Poorly laid out, overlapping functions. Finish level is old and outdated.

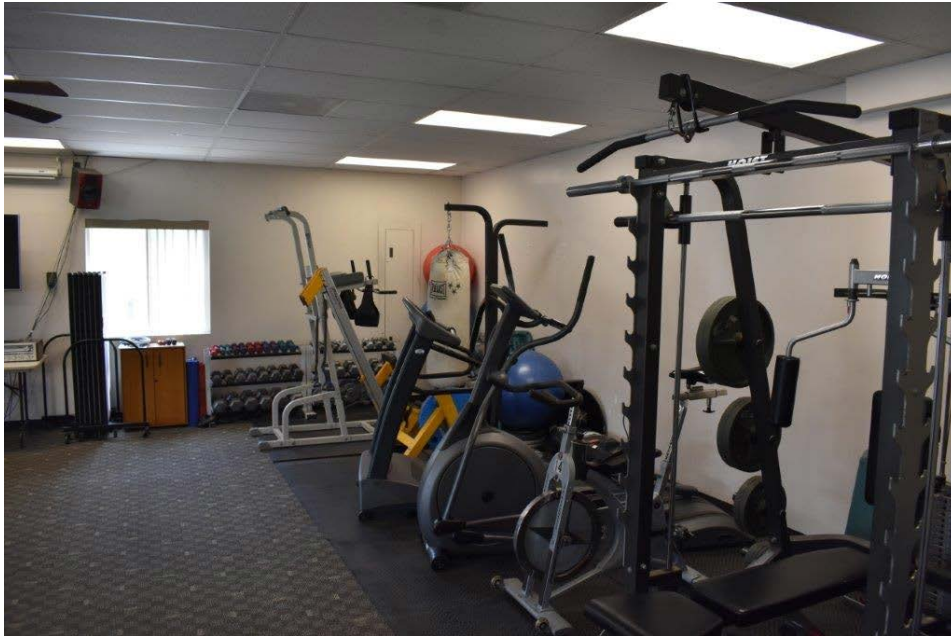
Picture #13.2 – The area is inadequate for the use as a PT area.

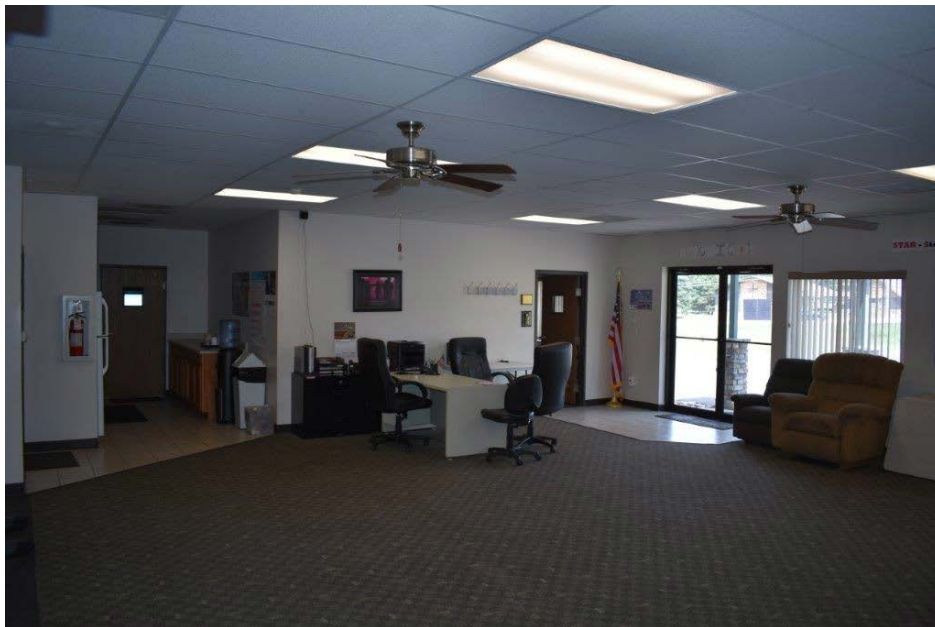
Picture #13.3 – Office area. No entrance vestibule, poor layout and use of space.

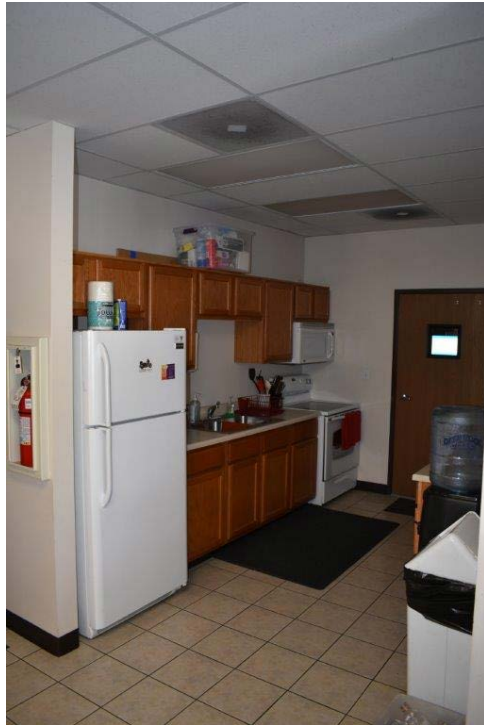
Picture #13.4 – Break area, no ADA compliant. Poorly laid out and in poor condition.

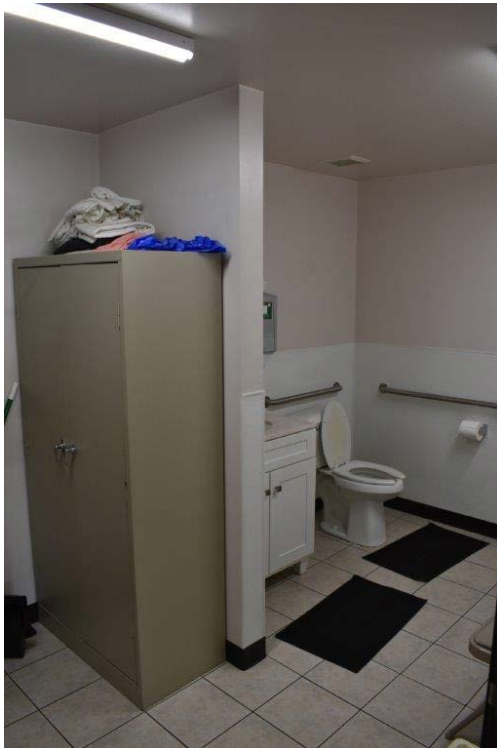
Picture #13.5 – Restroom facility, not ADA compliant, also used for storage. Based on the occupant load, the facility lacks the required number of restroom facilities as well. In addition the fixtures and finishes need updating and replacement.

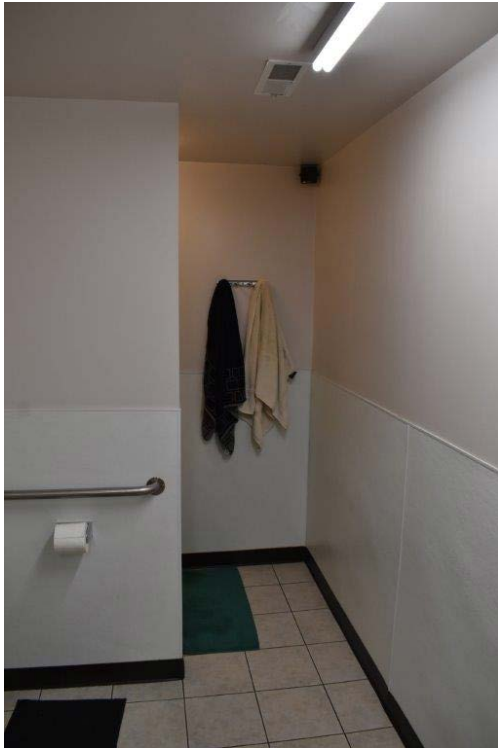
Picture #13.6 – Access to the shower is not ADA compliant.

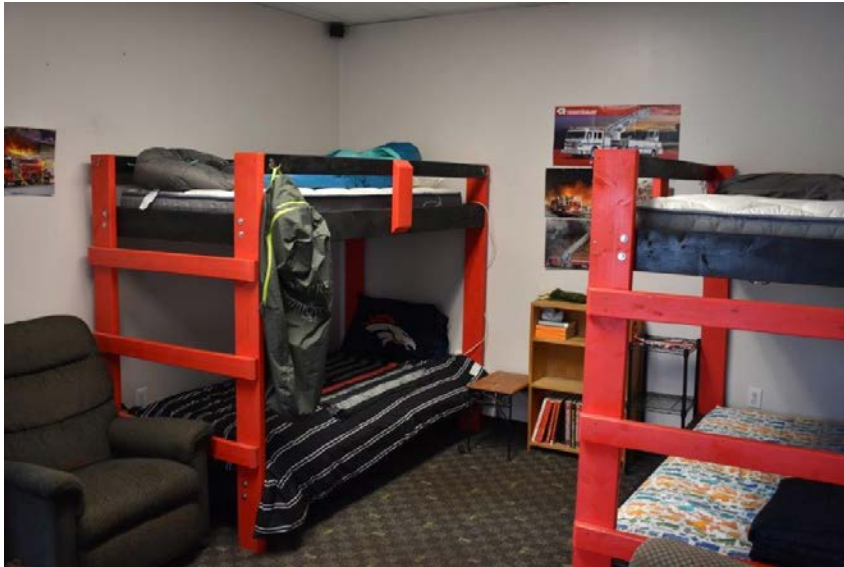
Picture #13.10 – The facility provides only one “crew bunk room”. Separate bunk rooms are required for men and women. Also the room is not code in terms of fire separation requirements and exits directly to the apparatus bay, causing a health hazard.

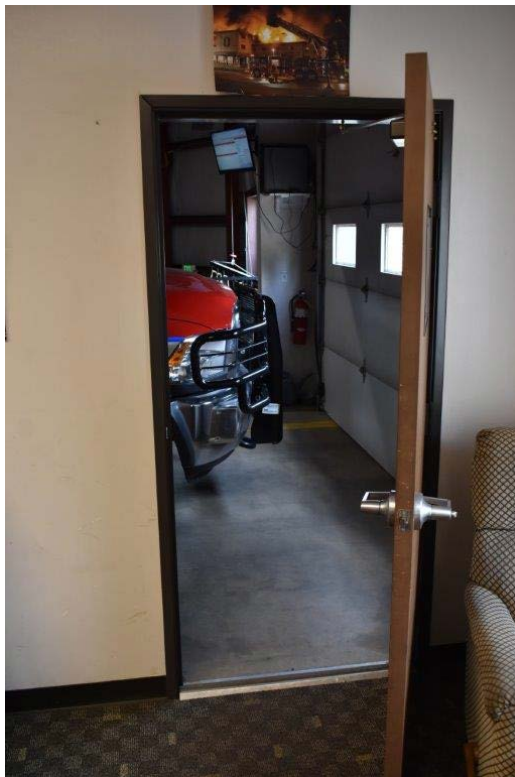
Picture #13.11 – Access door from bunkroom to apparatus bay. Door is not fire rated. Door does not provide a sealed separation between the “hot” zone and “cool” zone in terms of air quality.

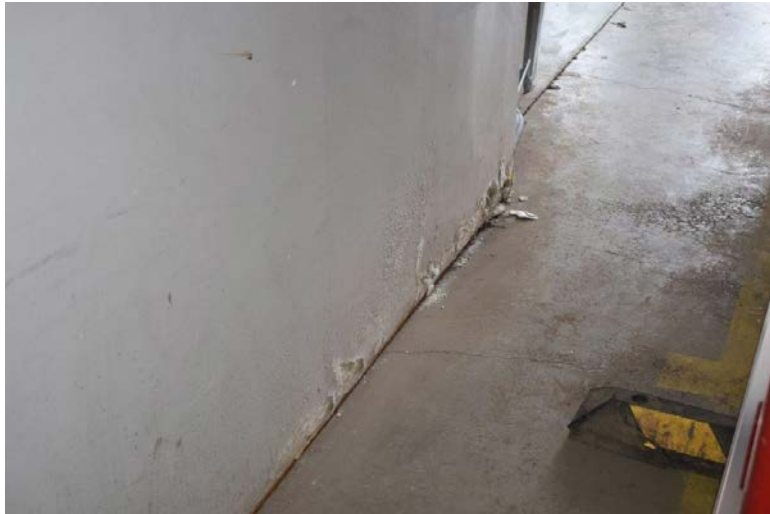
Picture #13.12 – Numerous areas of damaged drywall. This could be a prelude to mold concerns and possible indoor air quality concerns.

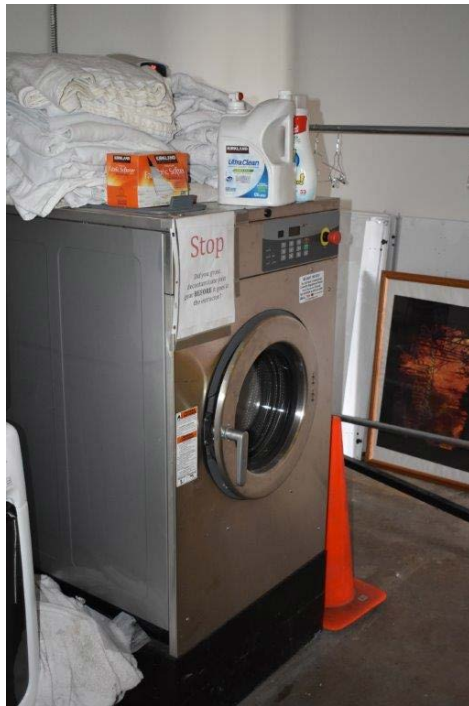
Picture #13.13 – Bunker gear washer. Improper placement, no storage space. Not plumbed correctly. Should be located in separate room outside apparatus bay.

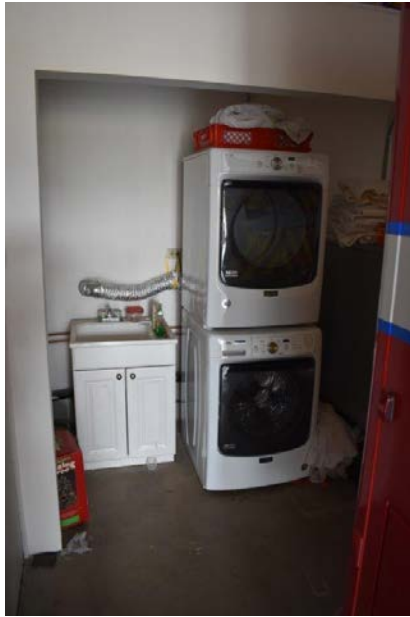
Picture #13.14 – Station wear washer and dryer. Should not be located in the apparatus bay. Also, lacks proper storage. Dryer vent is not code.

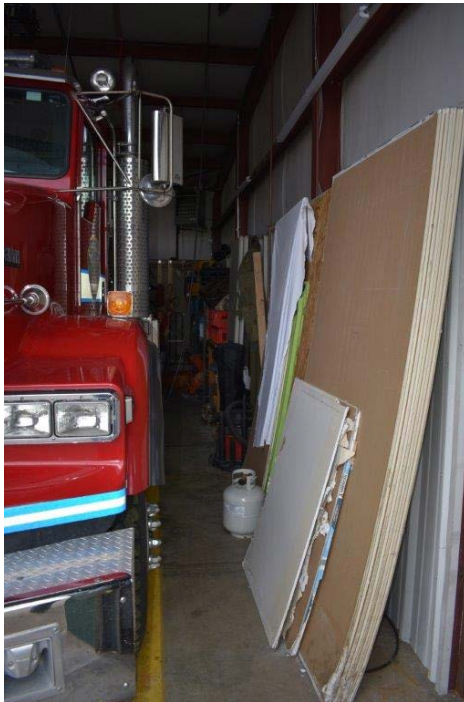
Picture #13.15 – Apparatus bay is used to store many unrelated items. This is hazard and reduces response times. Facility lacks ample storage.

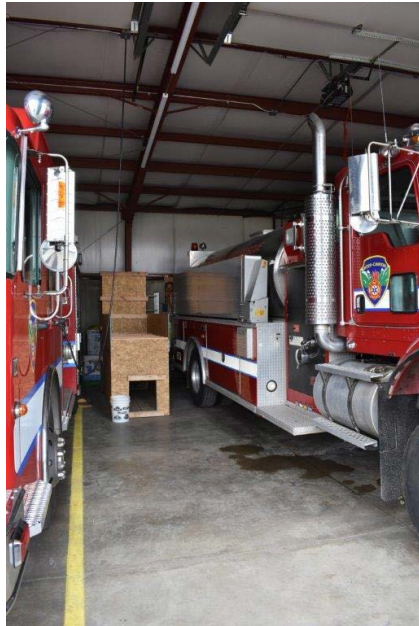
Picture #13.16 – Storage of props, as noted above, creates a hazard, reduces response times, can result in damage to the apparatus, etc. Facility lacks sufficient storage.

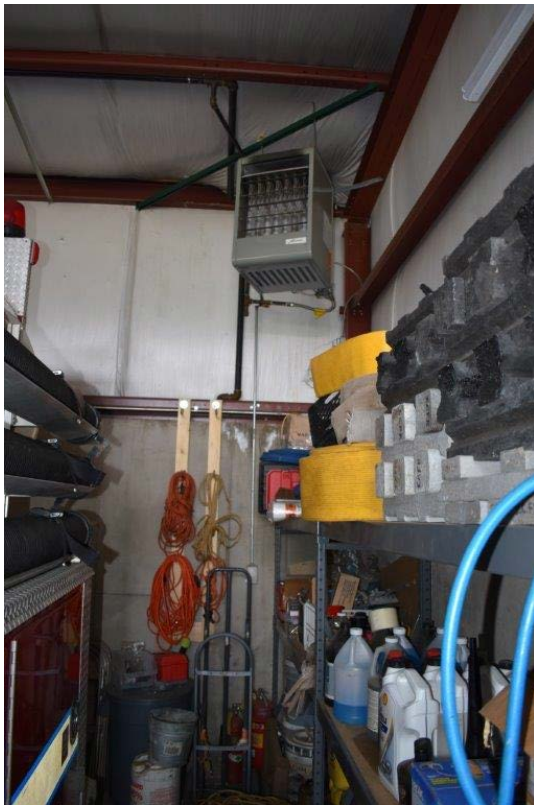
Picture #13.17 – More examples of inadequate storage space.

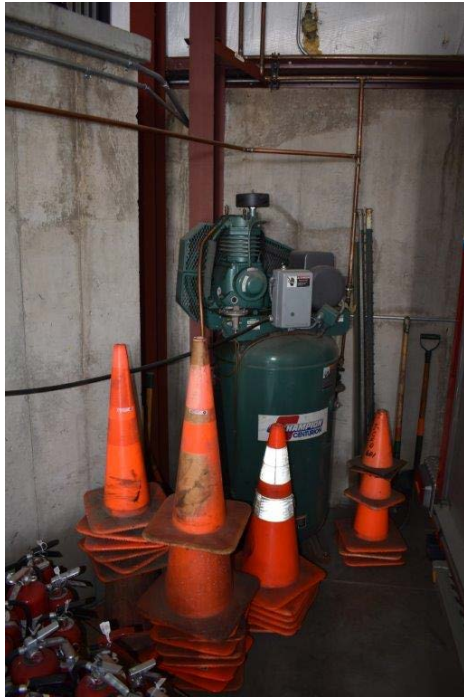
Picture #13.18 – Improper storage of equipment.

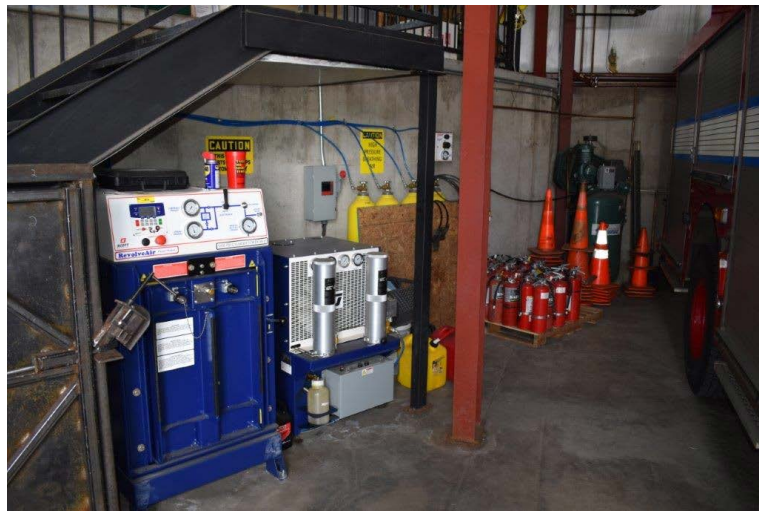
Picture #13.19 – SCBA equipment, improper placement of equipment. Items should all be properly stored and secured.

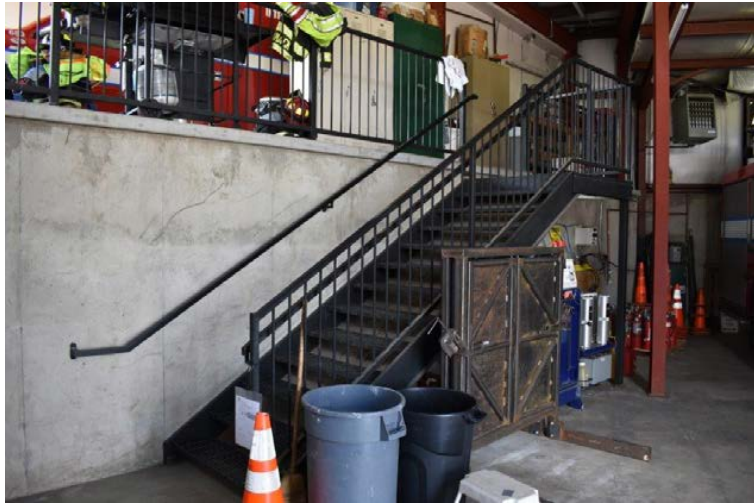
Picture #13.20 – Stair case between upper level and lower level. Stair case is not code. This also creates an ADA non-compliance issue between the two levels.

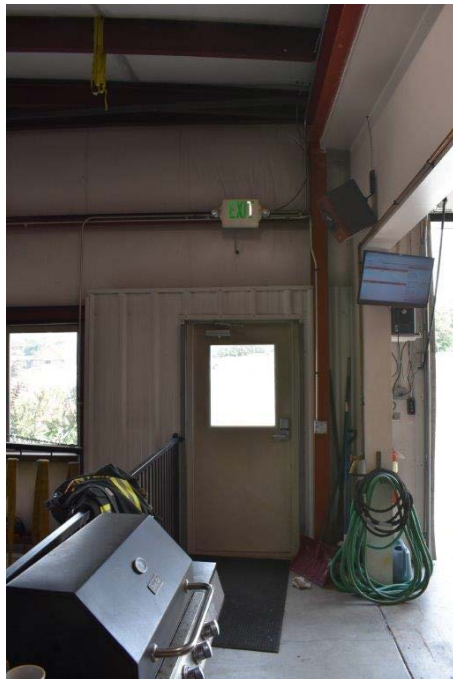
Picture #13.21 – Upper level, exit way is not “code” compliant. Also storage of items creates hazard.

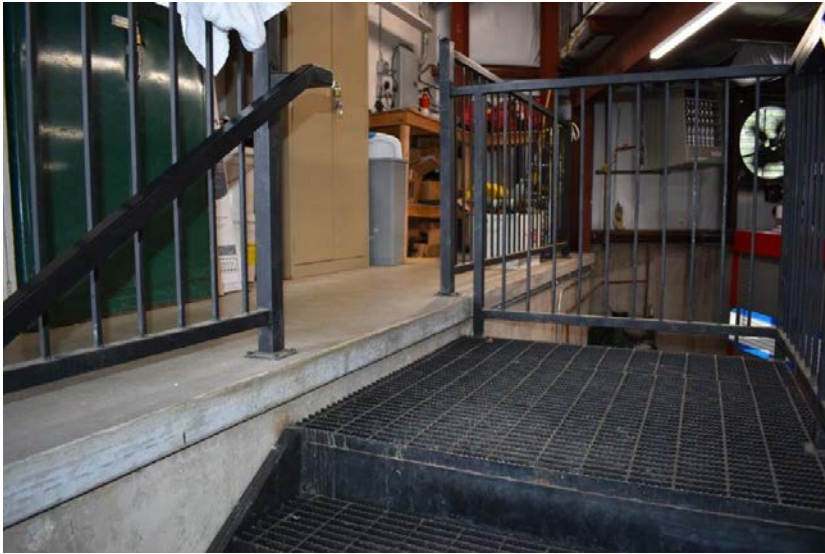
Picture #13.22 – Landing at top of staircase, is not code compliant. Landing should be co-planar with the floor, the current condition creates a hazard.

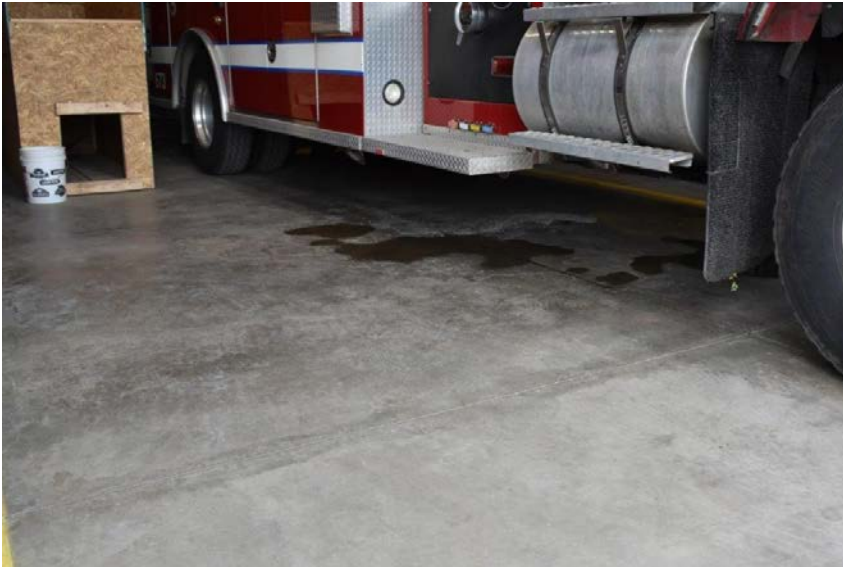
Picture #13.23 – Facility lacks proper floor drains. Standing water creates slip and fall concerns, a safety hazard.

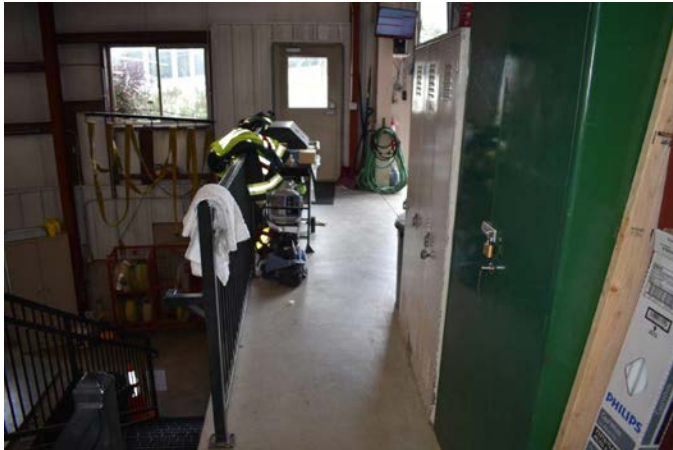
Picture #13.24 – Cluttered work areas, blocks exit passage.
